LEVEL 3 Your Survey Report

Property Address 42 Any Street
Norwich
NR1 1AA

Inspection date 14 October 1066

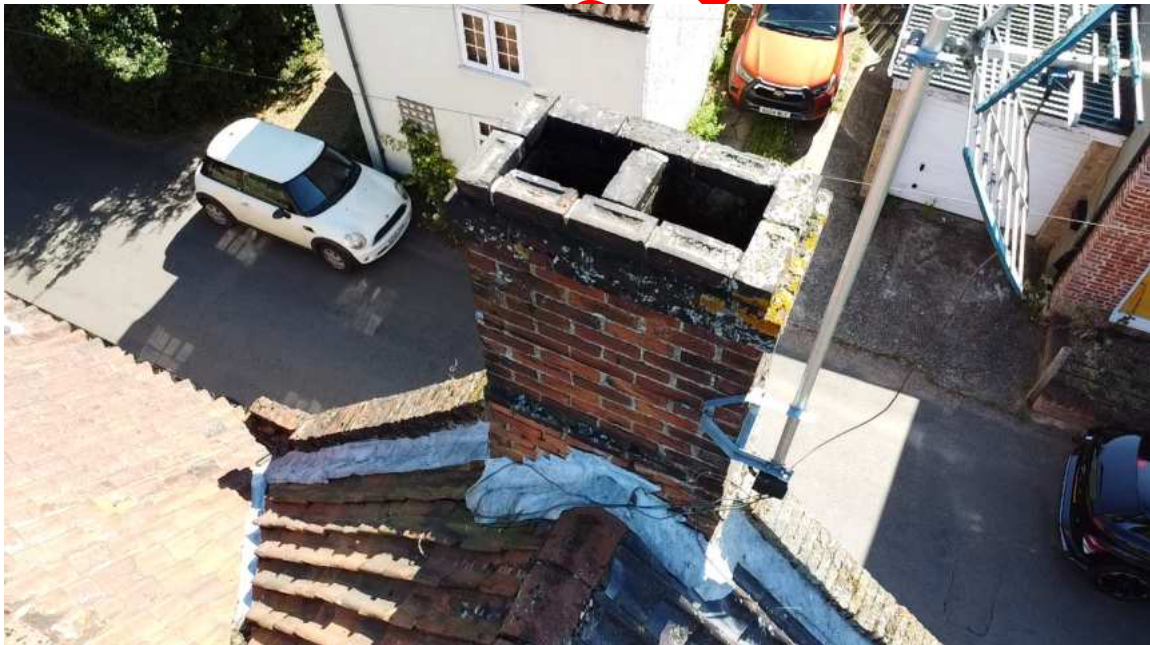
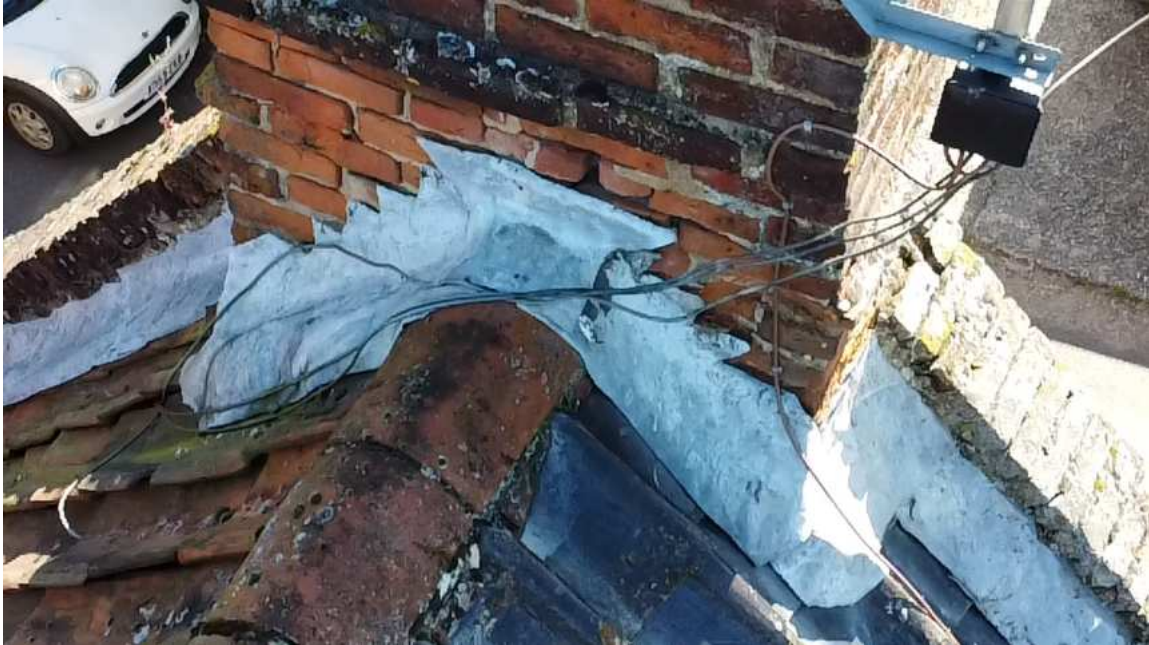
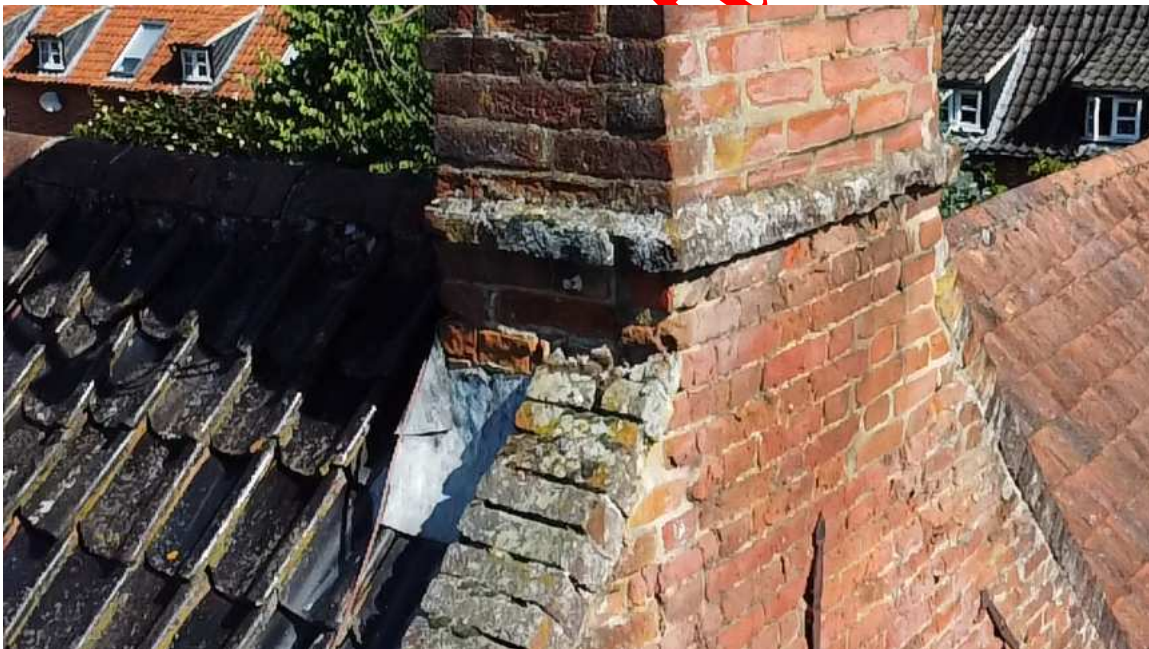
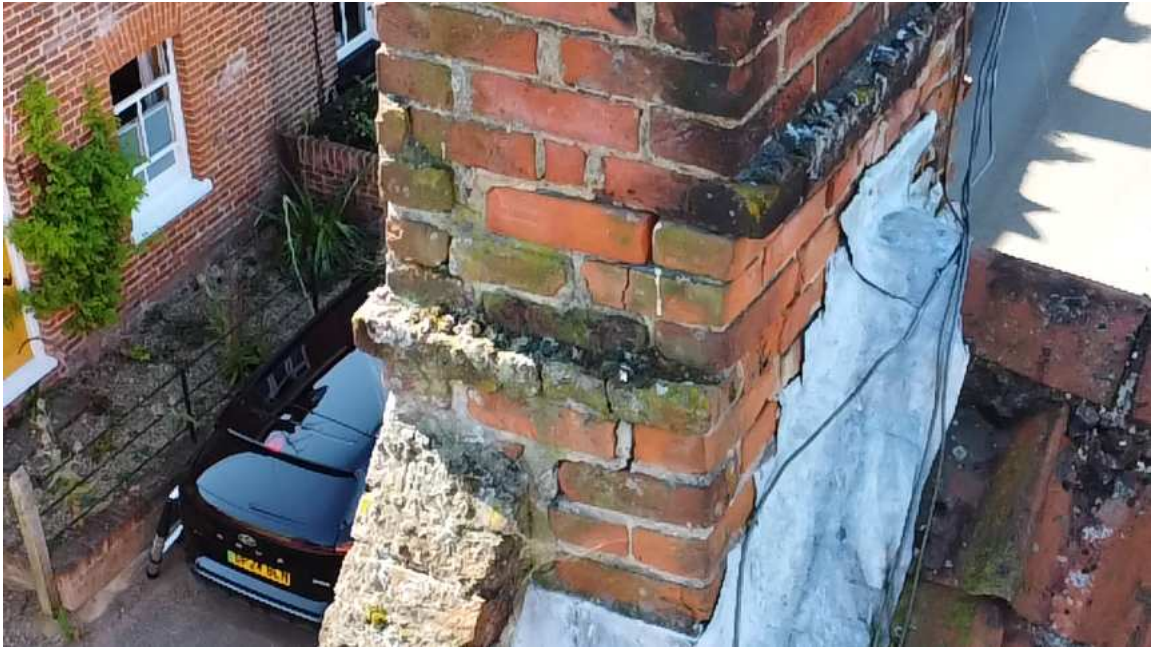
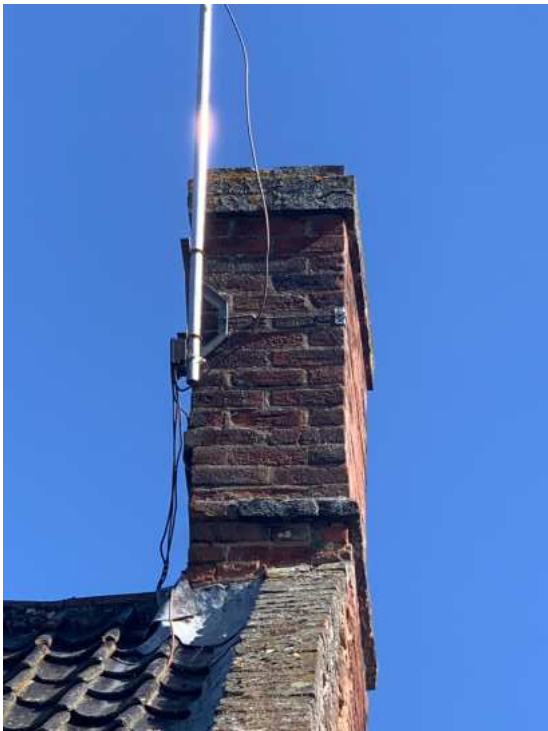
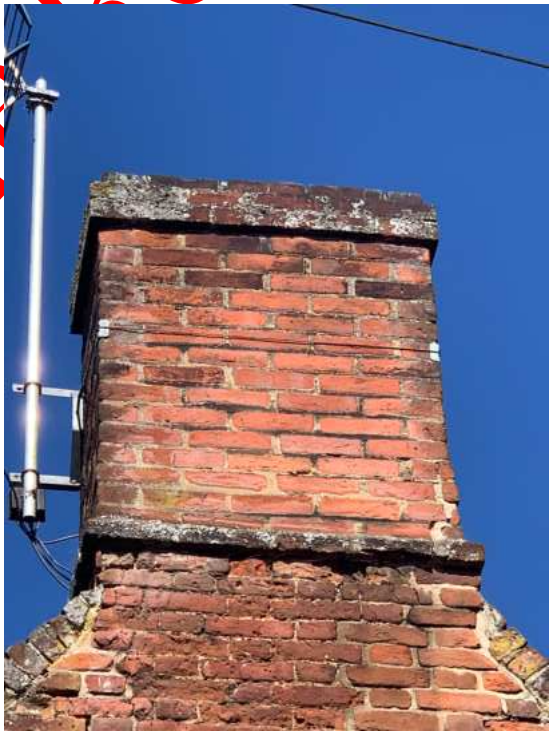
The property has a single chimney stack at the southeast gable end, carrying 2# open flues, and there is no flaunching present nor indeed any pointing to the brickwork at the top. Pointing is in very poor condition throughout and brick spalling is visible; some masonry is likely to be loose and hazardous. Flashings are in average condition and although generally dressed into place, major gaps are visible. There is evidence for historic repairs with cement mortar, which is inappropriate as the mortar will be harder than the underlying brick and is one likely cause of cracking and spalling to the brickwork.

Condition Rating 3.

Complete repointing is required now, including the capping of any unused flues and provision of ventilation from below (see E5). The chimney stack is slightly out of plumb also, and given its poor condition it may be more economical (or possibly necessary) to rebuild it in its entirety, which will require relevant consents as the property is listed. You must obtain quotations for these works prior to making a legal commitment to purchase.

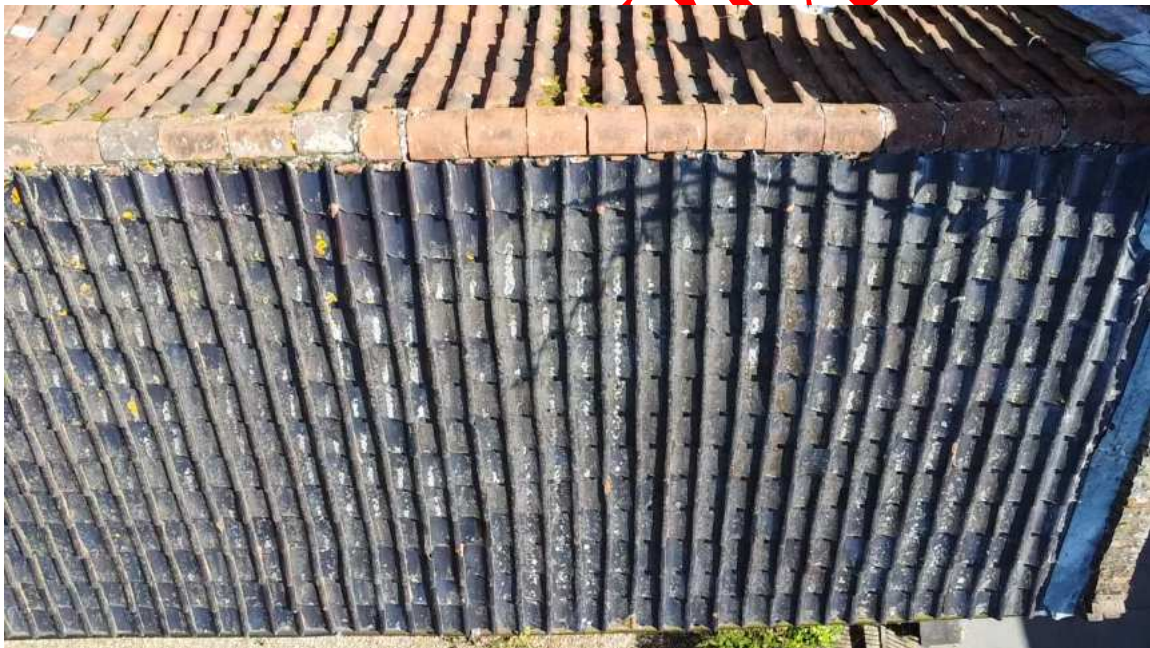
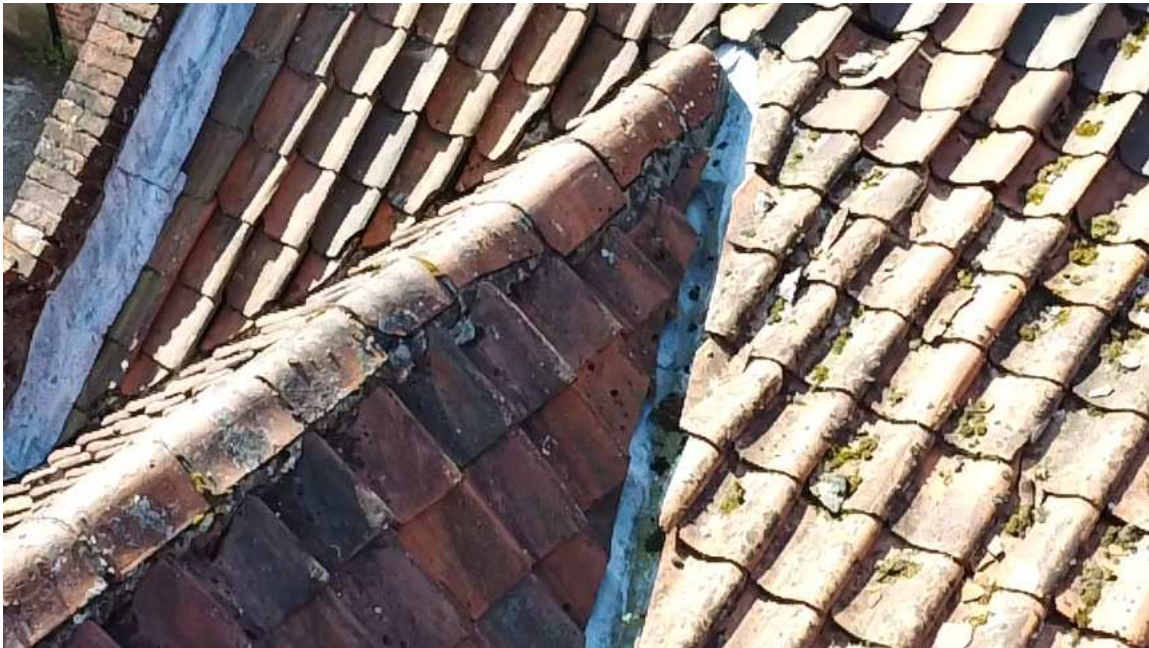
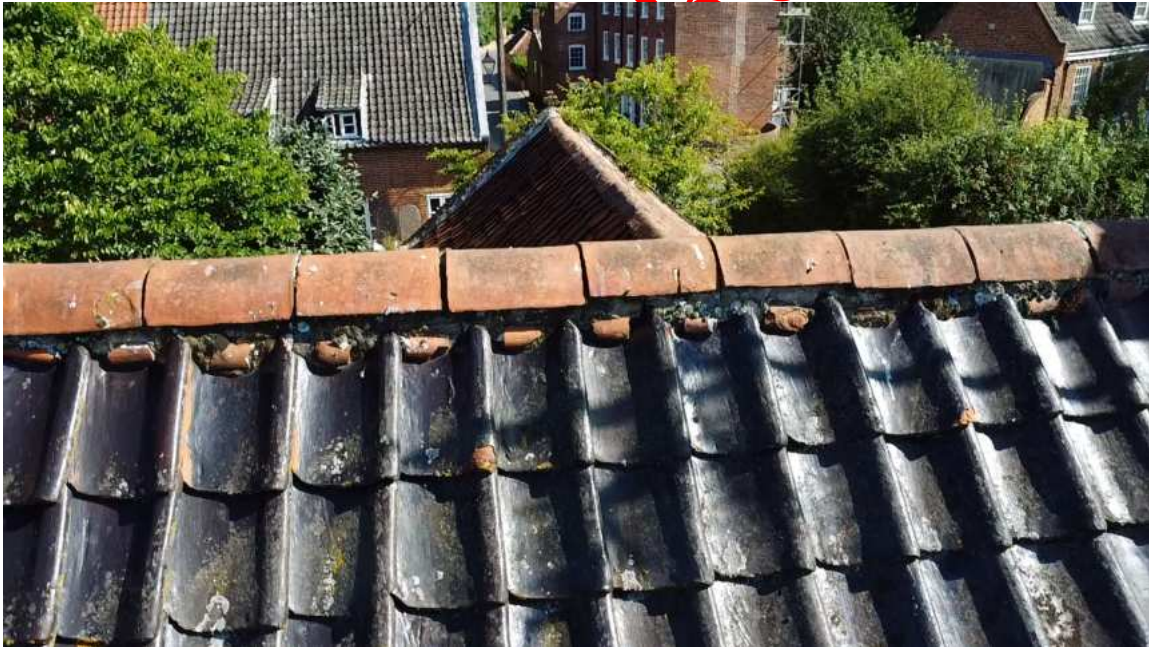
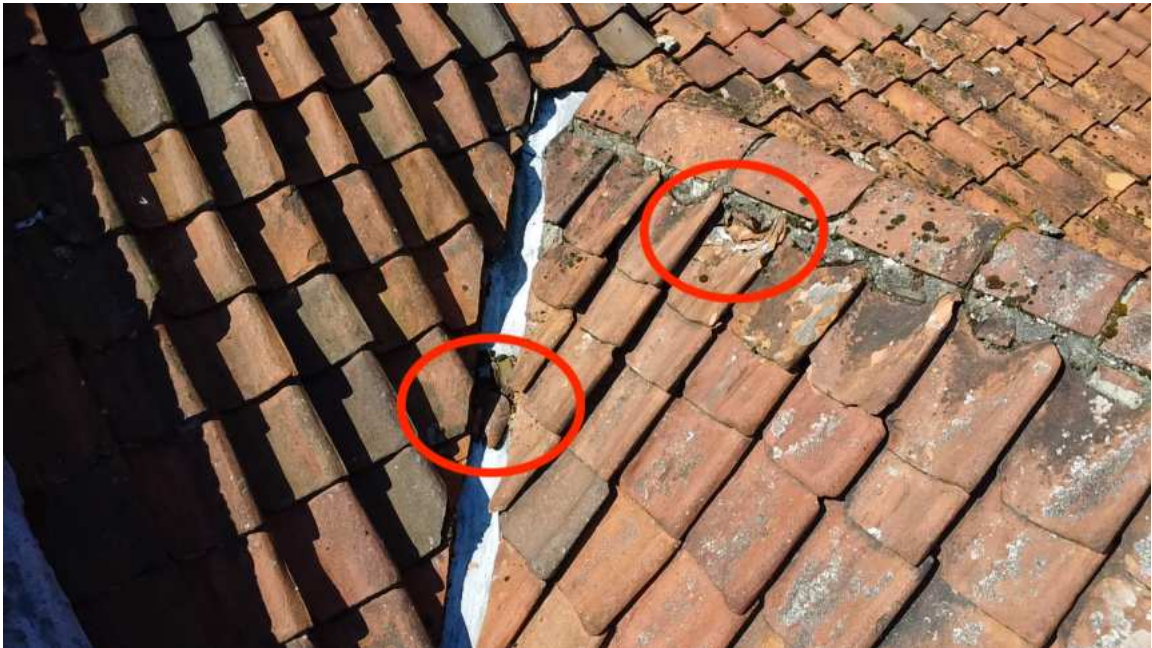
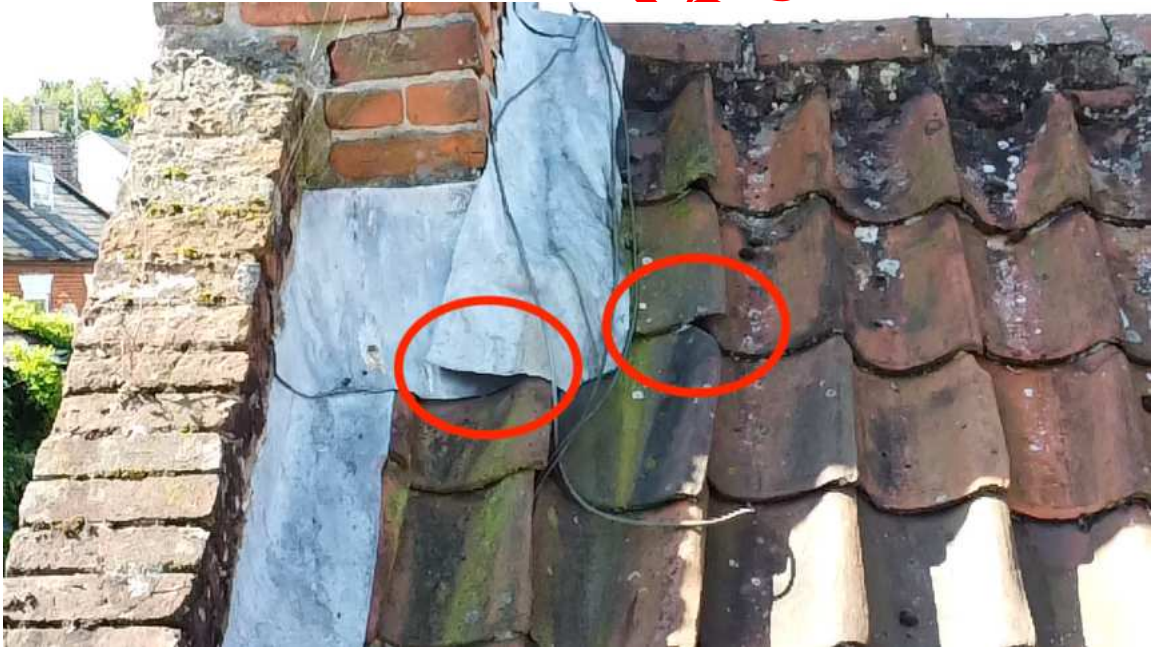
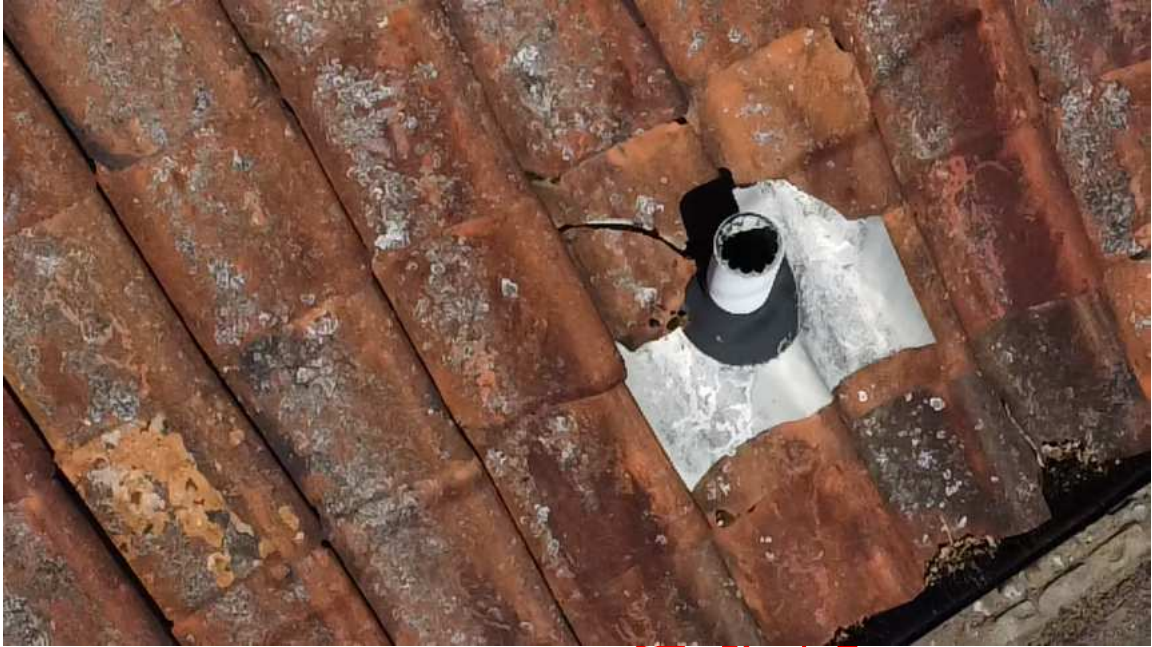
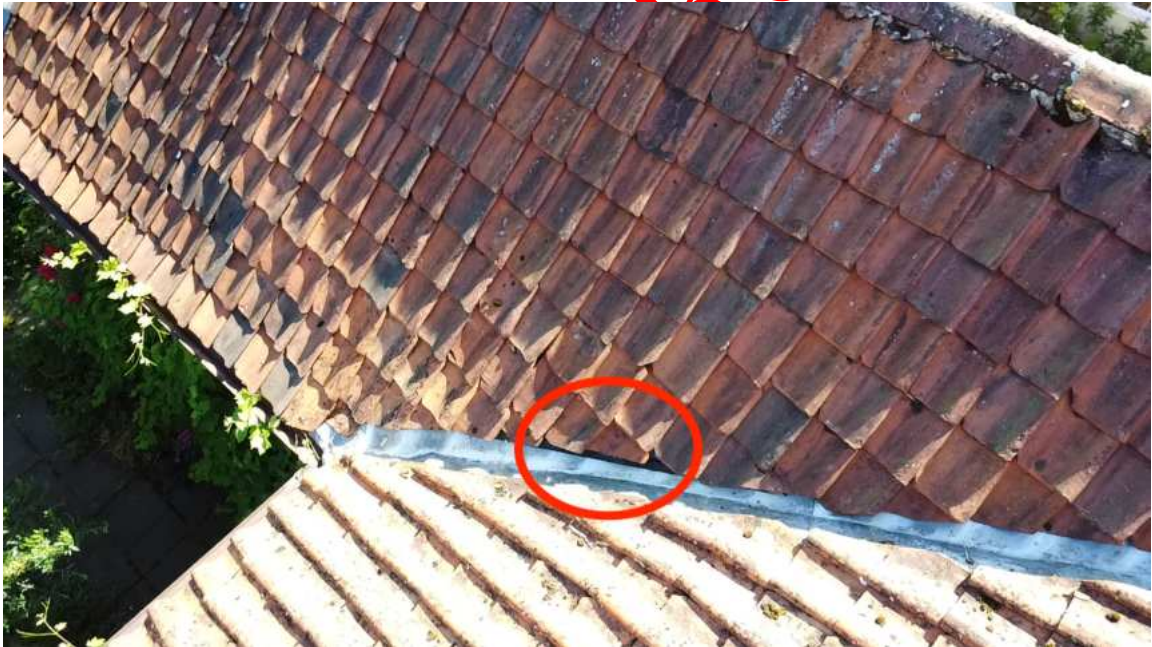
The main roof is pitched and clad in pantile. The main ridge runs north-south, with a section of east-west cross-wing adjoining #44. There is minor distortion commensurate with age throughout, as well as surface damage (known as 'shaling') occurring to the tiles, evident from debris shards across the majority of the roof and particularly visible at the rear. There is significant slippage of tiles which are generally poorly fitted, damage to ridge mortar, some cracked tiles, and untidy parapet flashings. As with the chimney, parapet brickwork is in very poor condition and requires complete repointing now. Valleys are damaged and blocked with debris; valleys are always potential problem areas and should be regularly inspected and repaired. There is also damage to tiles around the soil vent pipe (SVP) penetration, and trailing cables around the chimney, which can flail in high wind and catch tiles, causing slippage and cracking as well as a risk of falling debris to passers-by below.

Condition Rating 3.

The roof is past its serviceable life and requires recovering now to stop further damage and prevent leaks. Given the extensive wear it is possible some underlying timbers may need replacement also. You should not proceed with the purchase before obtaining quotes for these works from a competent contractor, including allowing for all relevant consents as the building is listed and in a conservation area.

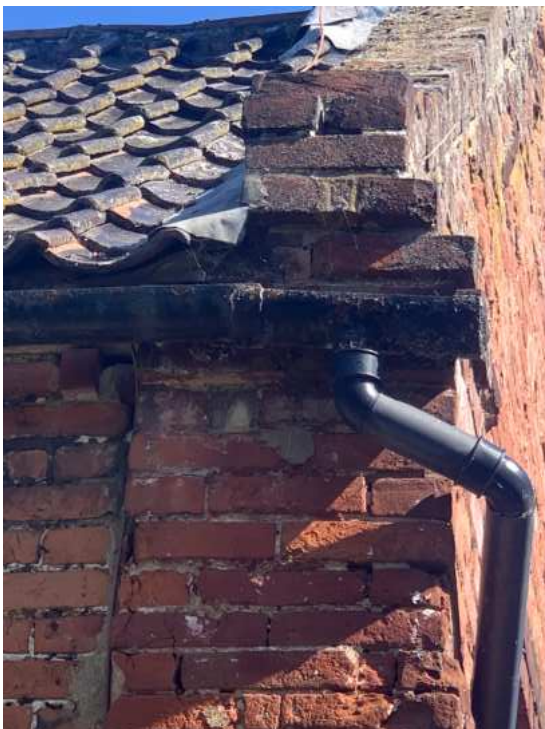
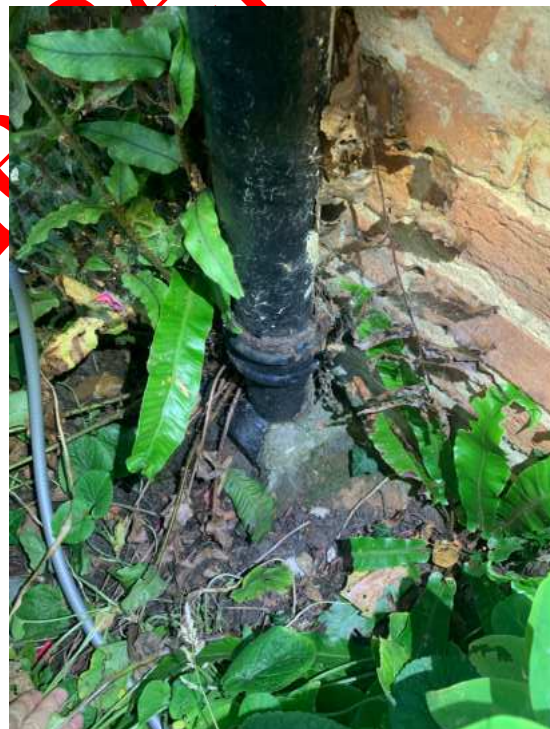
Guttering is predominantly cast iron and in very poor condition throughout. Gutters connect into PVC downpipes, which are aged and likely to be brittle, and also their rubber seals are likely beginning to perish, which will lead to leaking from the joints.

The northwest corner downpipe discharges directly to the ground. This can result in dampness to walls and softening of the ground beneath the foundations. The downpipe should be extended to discharge directly into the below ground surface water disposal system, preferably via open gulley with grille that can be visually inspected and maintained easily.

Condition Rating 3.

The rainwater goods are showing signs of deterioration and failure, and a general overhaul is now recommended. Complete renewal is likely to be more economical than localised repair and you may find that replacing cast iron elements with modern PVC components is more cost-effective. Consents (conservation area, listed building) may be required.

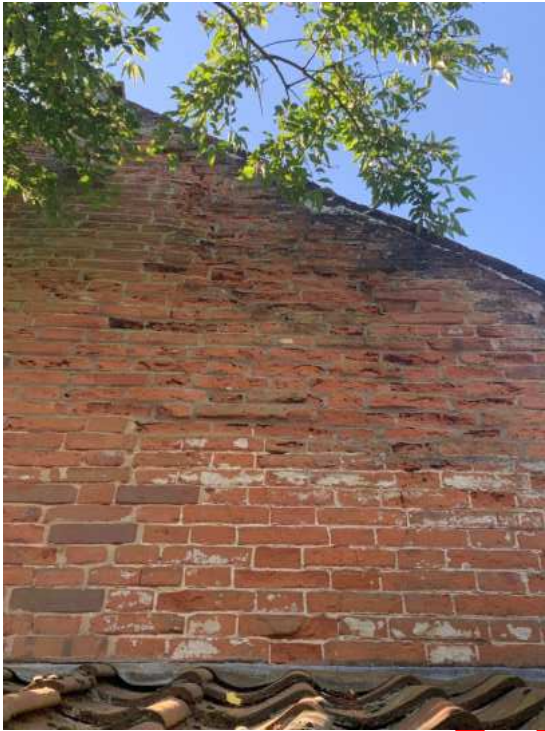
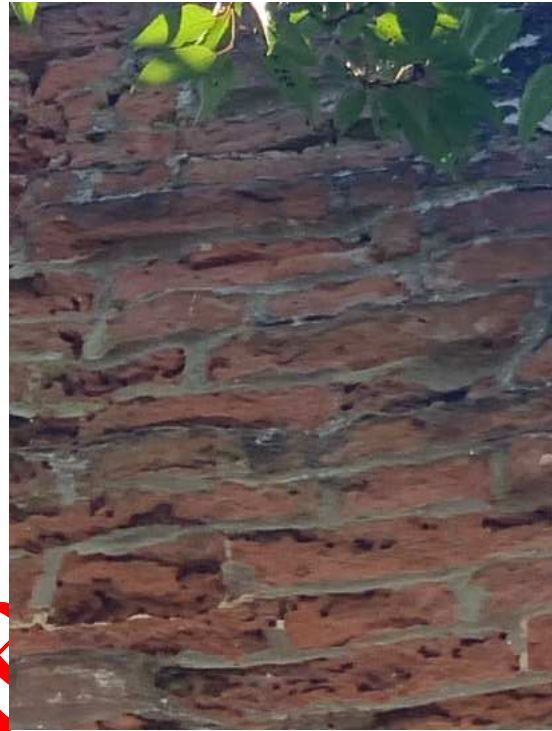
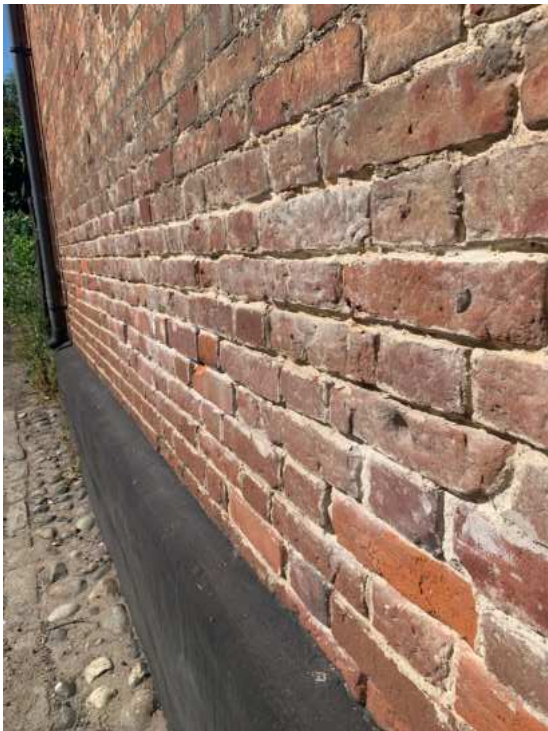
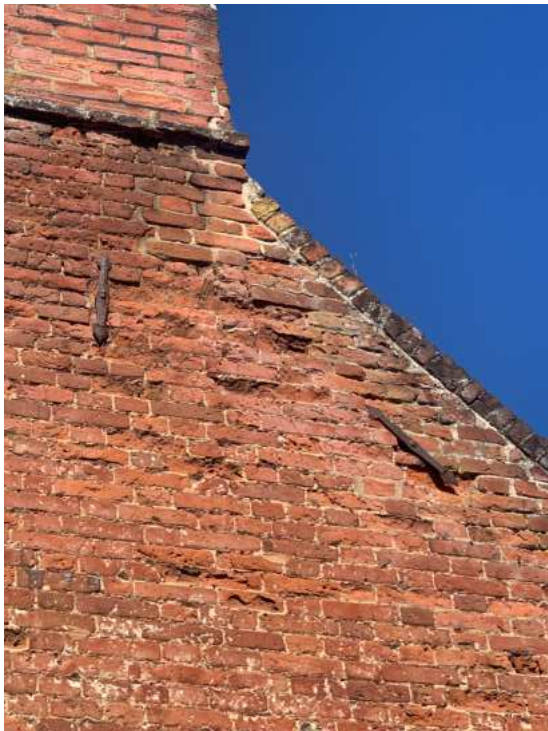
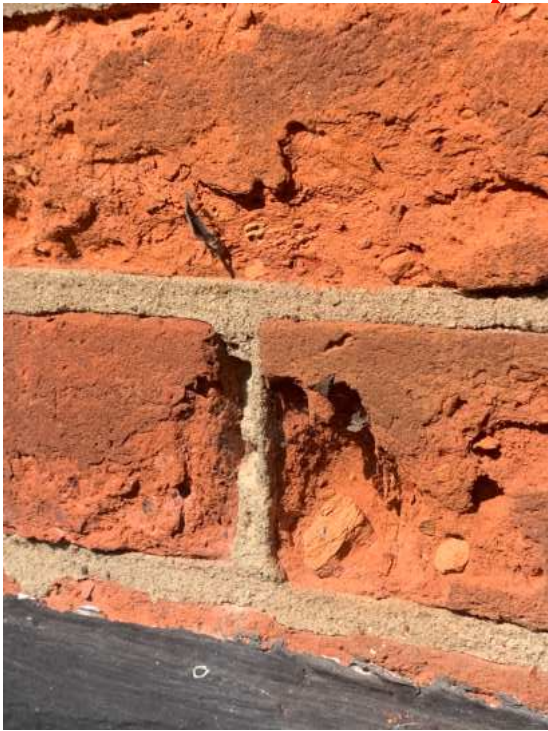
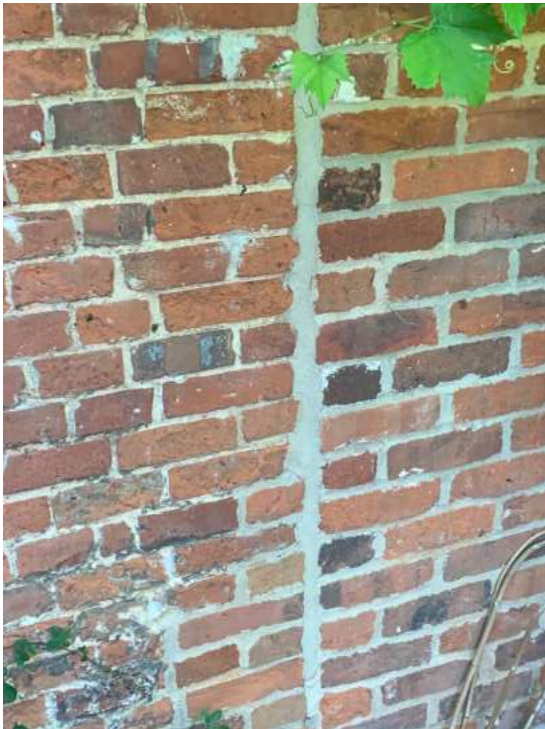
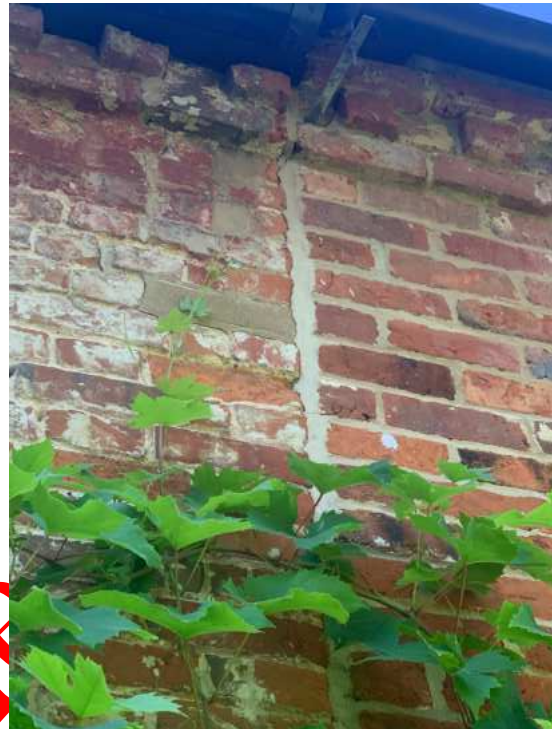
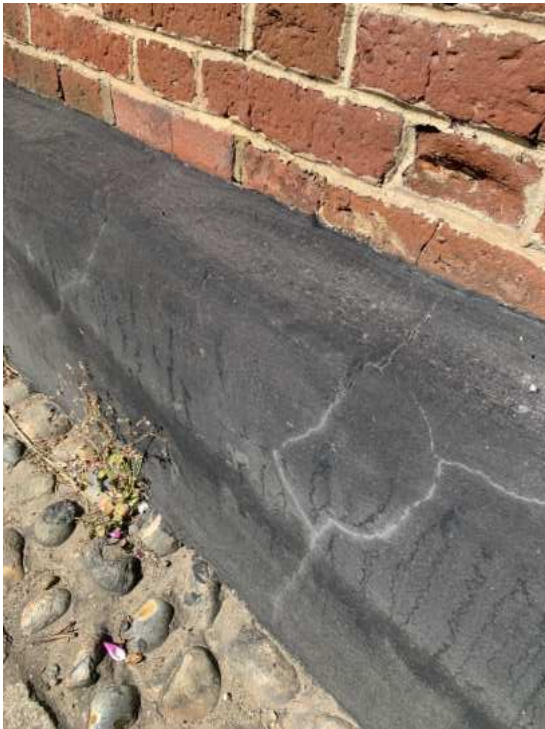
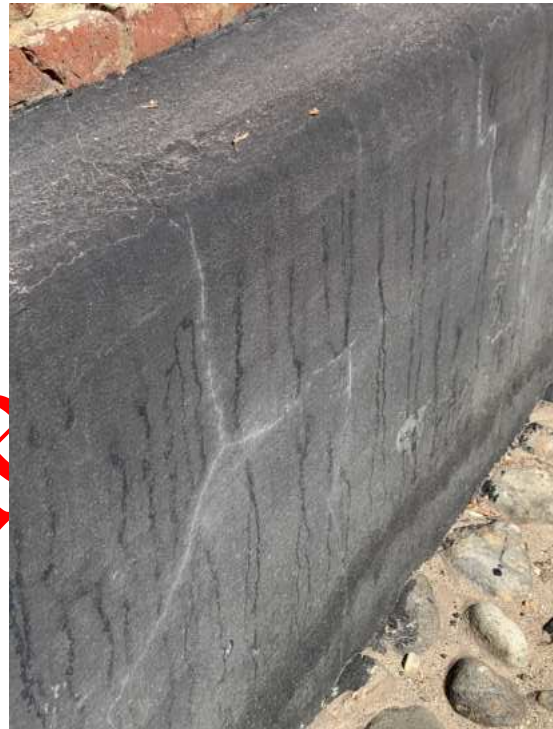
The main walls are built of solid brick laid to Flemish bond (long-short-long) with flint dressings. Pointing is in generally very poor condition throughout, with extensive failures and spalling across all elevations. Major spalling and failure is particularly evident at the east and north gable ends, and brickwork is soft to touch; a video file will be provided along with the PDF copy of this report.

Where the subject property joins #44 at rear the junction appeared in generally satisfactory condition with no major cracking noted, however, these areas and other pointing repairs have been done in cement mortar, which is inappropriate as the mortar will be harder than the underlying brick and is likely at least in part the cause of cracking and spalling to the brickwork. There are historic wall ties present and evidence of numerous phases of localised repair.

A rendered plinth is positioned at low level. Rendered plinths are no longer considered to be an effective measure to prevent penetrating damp from passing through a solid wall. Instead, this can only magnify the problem, as moisture can become trapped behind the non-porous render and is instead forced towards internal areas, causing damp to form on connecting building elements and often remaining unnoticed until significant problems manifest. The render to the plinth is in generally poor condition also. Where walls are rendered we cannot comment on the condition of walling beneath and it is possible that the rendering may be concealing distortions to brickwork or other defects. It is recommended that the render be regularly coated with good quality masonry paint as its integrity is vital. Once water penetrates its external surface then damp is likely to occur internally and the render itself will continue to deteriorate.

Condition Rating 3.

The walls are generally in need of complete repointing in lime mortar, and extensive repairs to prevent further deterioration and water ingress (see also E3). Works will require raking out of the existing pointing by hand and are likely to be extensive and costly, you should obtain quotations from a competent contractor prior to making a legal commitment to purchase the property.

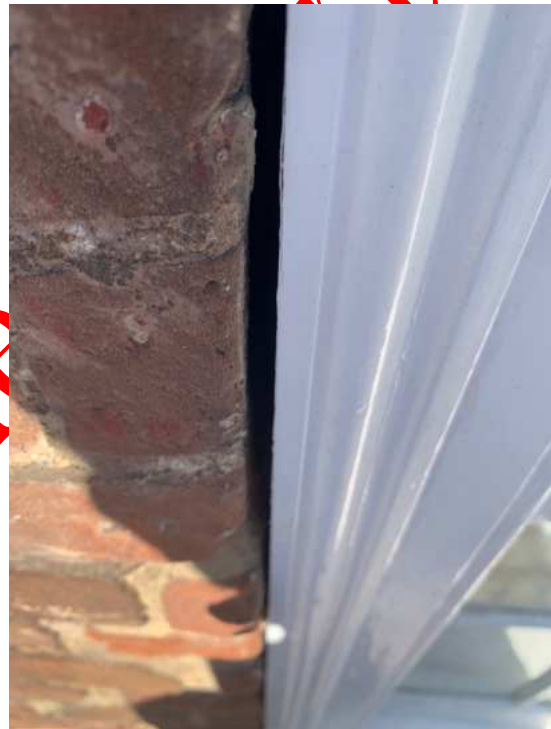
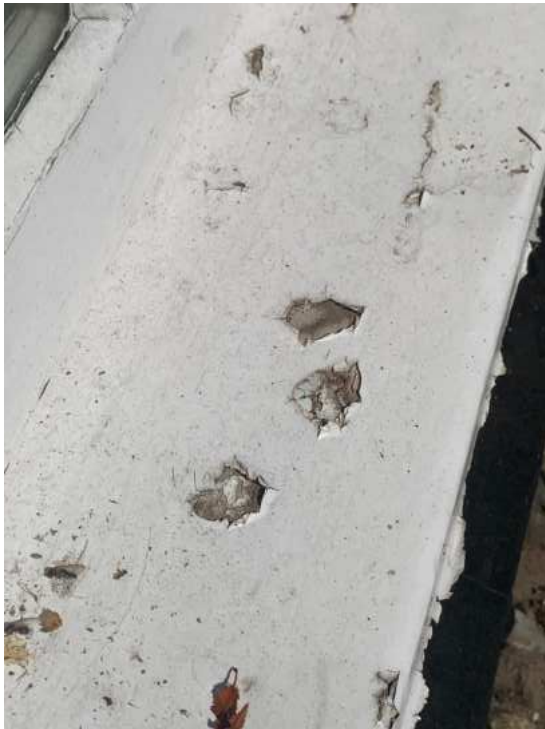
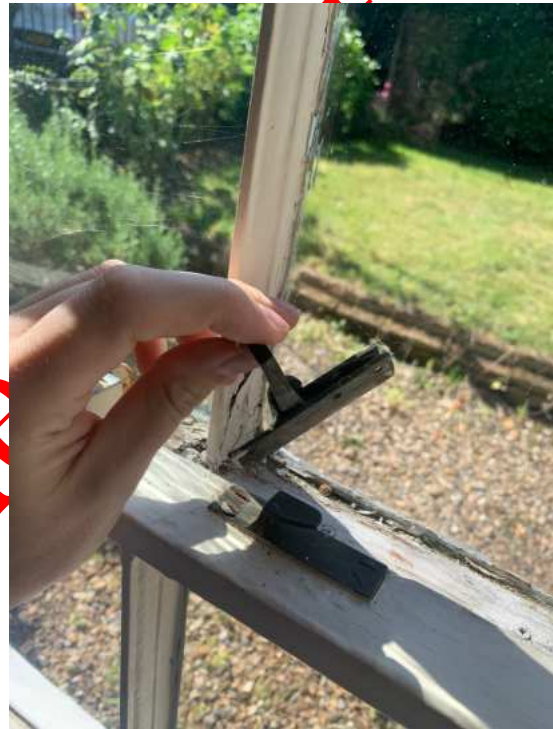
The windows are timber-framed, single-glazed units, a mixture of sashes and casements. They are in generally poor condition throughout with decorative failures and the onset of wood rot, as well as gaps to edges. The majority were either painted shut, had broken mechanisms, or were locked and could not be tested; only the 1st floor stair window and the window of bedroom 3 could be operated during our inspection.

Condition Rating 3.

It is unlikely to be economical to attempt repair of the existing windows and total replacement is now recommended. You should obtain quotations for these works prior to making a legal commitment to purchase the property, and consents (e.g. conservation area, listed building) will be required also. Replacement presents an opportunity to upgrade the property's thermal performance and ventilation.

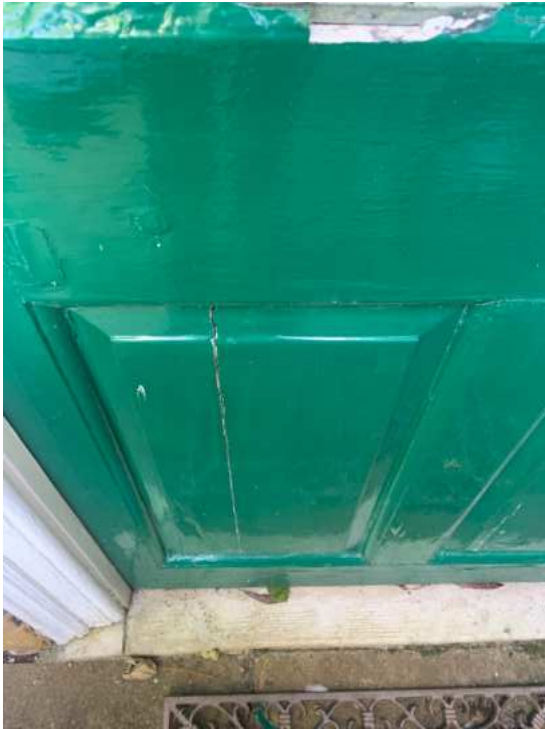
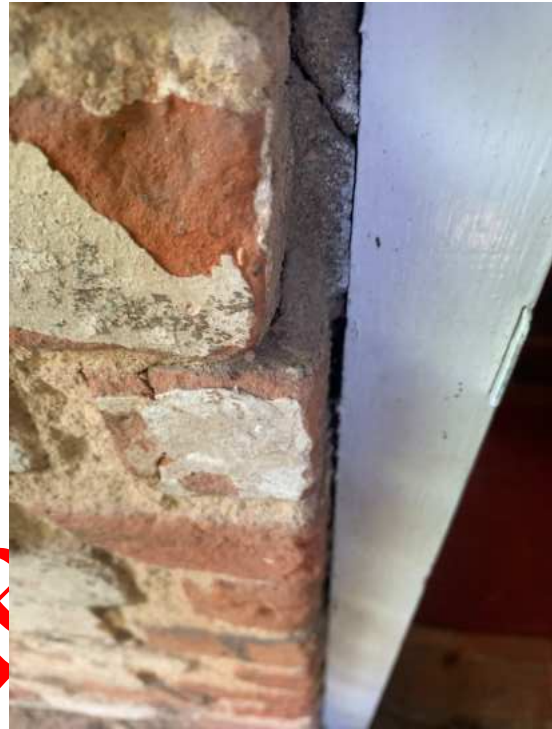
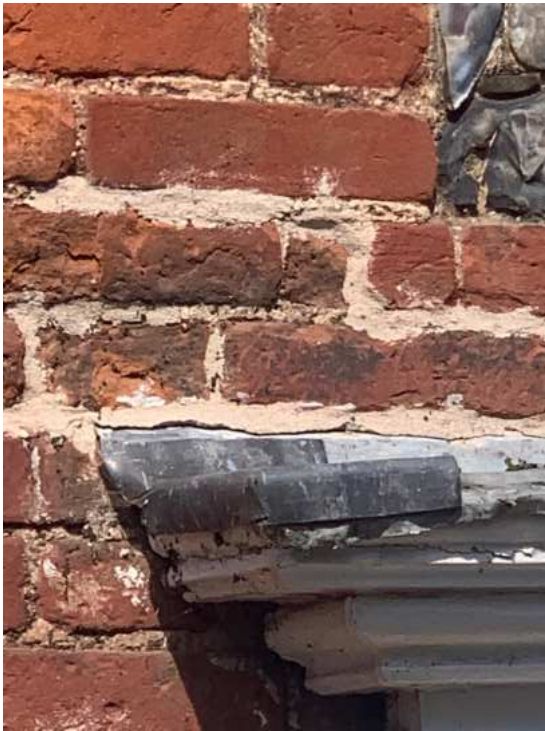
The north door is built of hardwood timber with single-glazed vision panel and appears to be in generally average condition, with minor damage to the door leaf itself, putty failures, and edge grout that is poorly dressed and gappy. There were no visible signs of damage to the glass. The cill is intact and in good order, however, would benefit from a metal threshold plate to prevent wear to the timber. The door opened, shut, and locked cleanly.

The west door is of similar construction and in generally similar condition, although with evidence of swelling and distortion and damage to putty seals. This door was not tested for operation as no key was provided.

The east door is also of hardwood construction and is in similarly average condition, with evidence of pointing failures at the flashing above the case, consistent with the very poor quality of brickwork and pointing generally (see D4, above). There is a step directly through the threshold which may prove a fall/trip hazard, and you should consider your occupancy requirements in this regard.

Condition Rating 2.

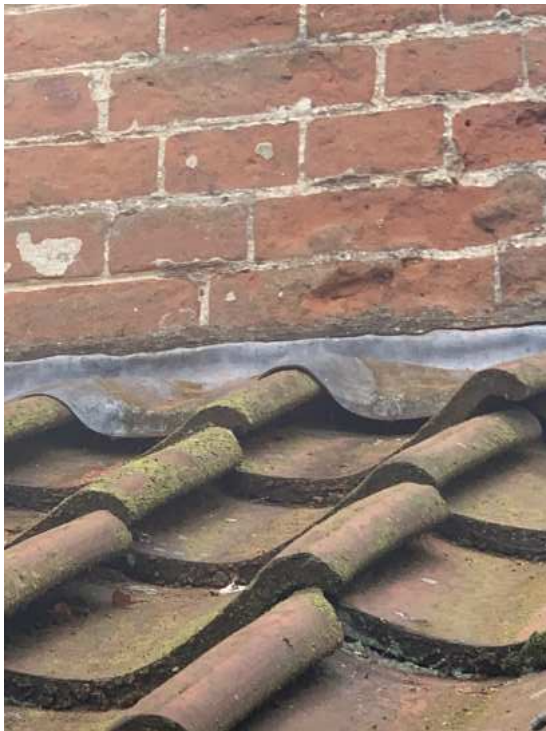
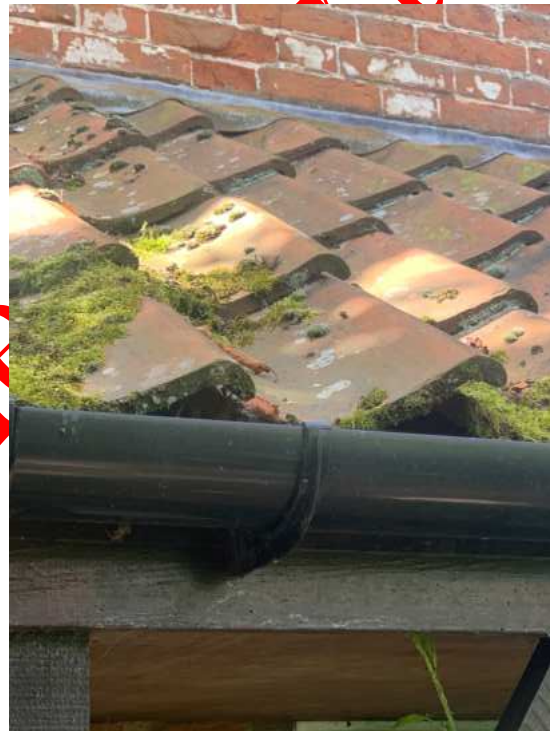
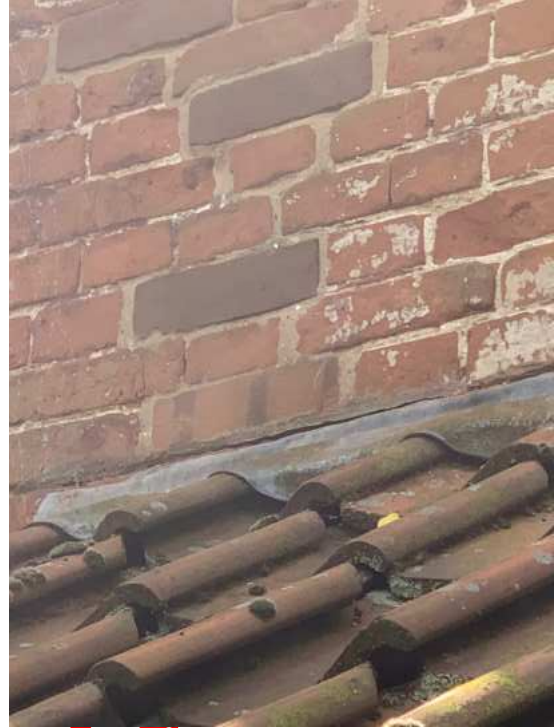
The property has a timber-framed porch with pantile roof at the north, which is in generally average condition. Roof tiles have slipped and are poorly fitted, and also show evidence of shaling as per the main roof. There are pointing failures at the junction with the rear elevation as well as gaps to the flashing. There is some moss and lichen growth. This should be removed periodically as it inhibits roof efficiency and could lead to rainwater goods becoming blocked. The guttering discharges directly to ground also (see D3, above), although the surface area of roof served by the downpipe is small. The soffit is in generally satisfactory condition, however, it is likely given the condition of the roof that leaks may be occurring above that are not visible at this time. A programme of localised repair is recommended now, and quotations should be obtained prior to exchange of contracts. The rainwater butt was not inspected in detail.

Condition Rating 2.

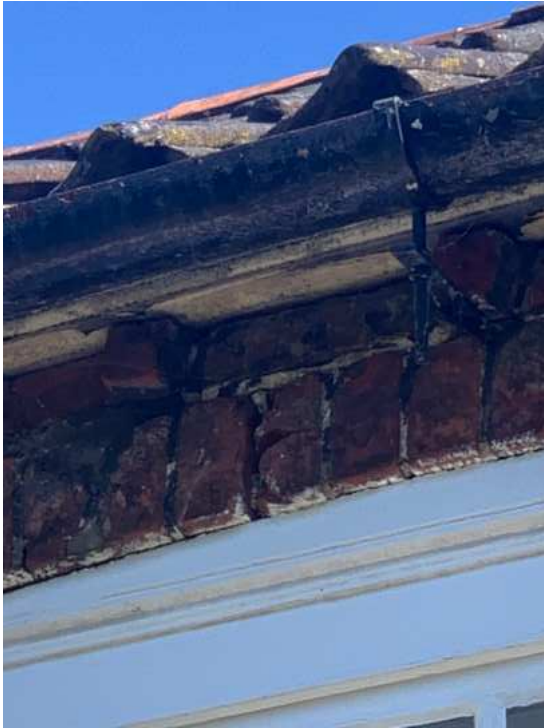
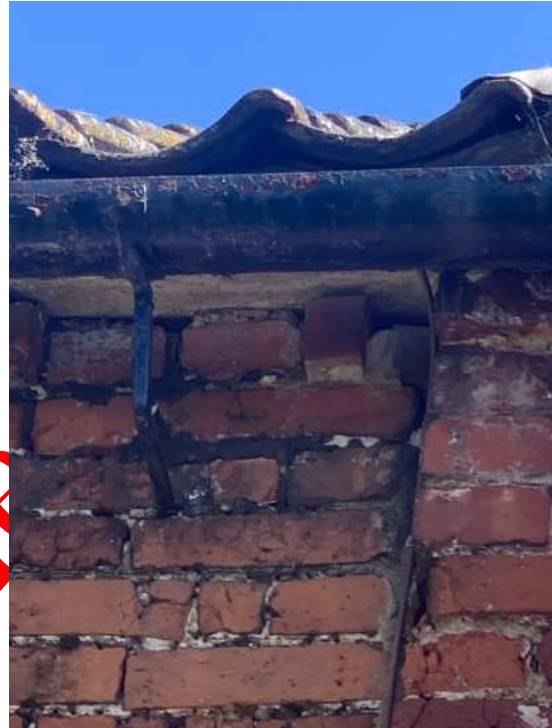
The property has limited areas of timber fascia and soffit that are in generally poor condition with evidence of wood rot. In view of the age and condition of the gutters we consider it possible that areas of hidden wet rot may well exist in fascia boards hidden behind the gutters and brackets also. Exterior timber joinery components require regular redecoration to prevent wood rot and ensure good aesthetics, and any quotations for roof and chimney works should include for replacement of guttering and fascia as required.

Condition Rating 2.

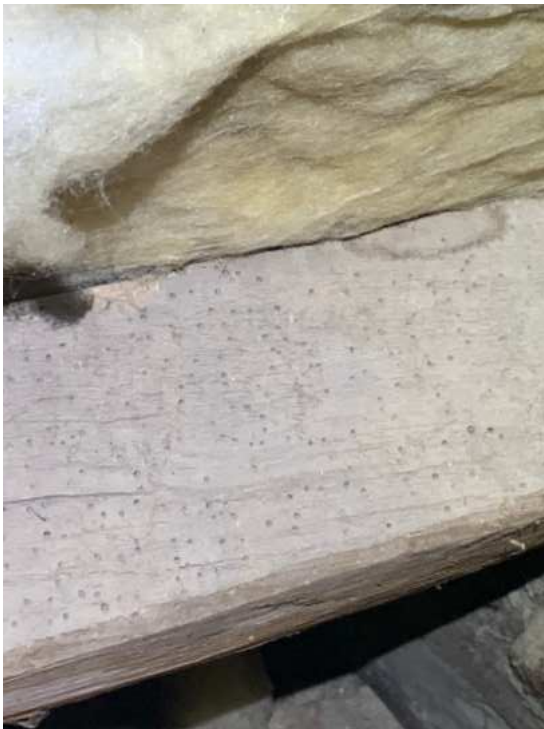
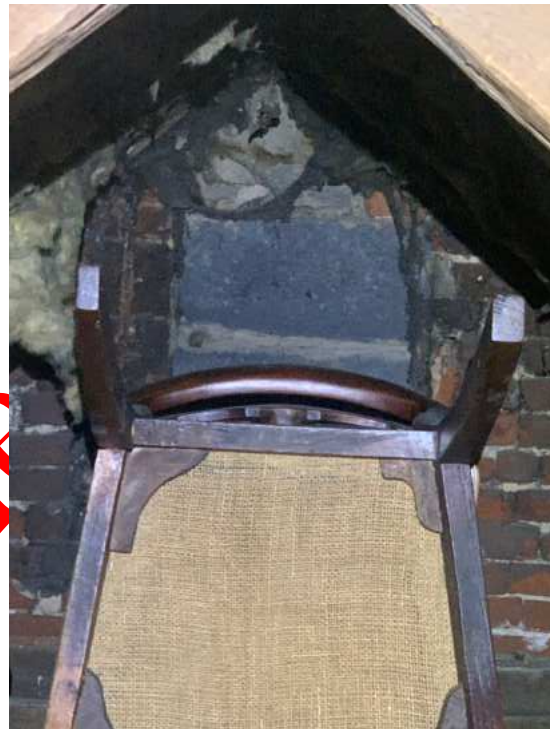
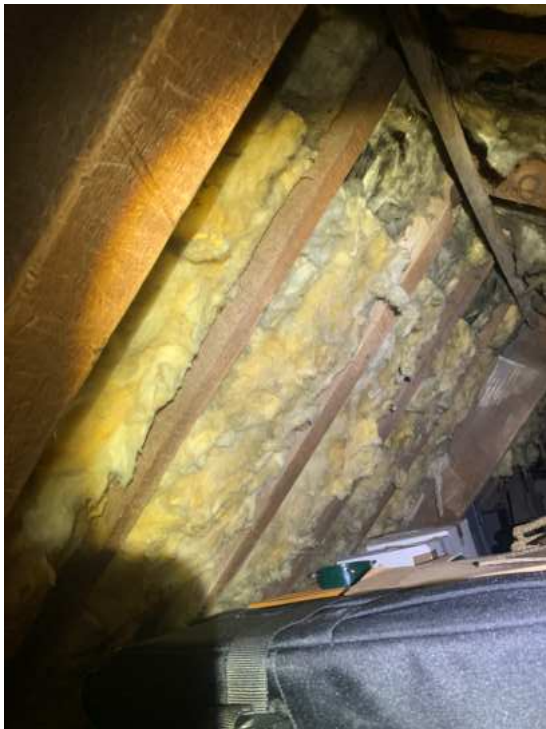
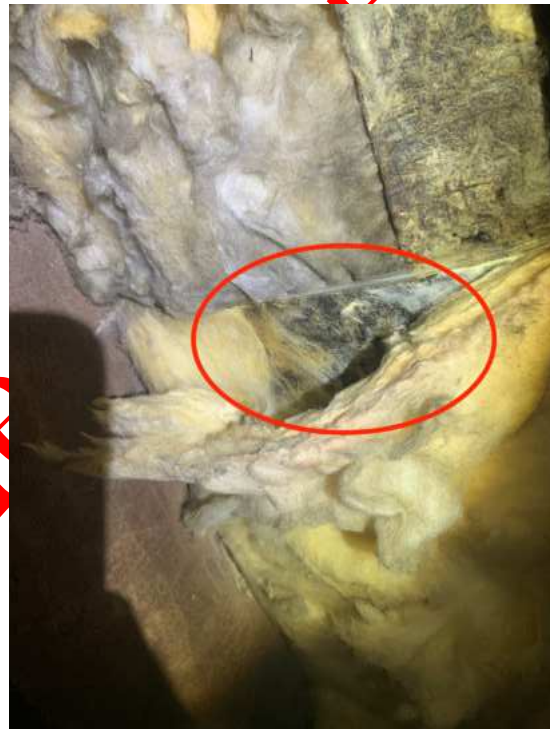
The main roof is of rafter and purlin timber construction, typical for a house of this type and age. There is no ladder and no light. We noted minor deflection to timbers commensurate with age (see also D2), but no evidence of vermin. We found signs of historic wood boring beetle (woodworm) infestation, and older properties such as this one are always susceptible to attack in concealed areas such as lofts and floor voids. As per our advice in B – Further Investigations, above you may therefore consider it prudent to instruct a timber specialist to report specifically on these issues and ask your legal advisor to obtain copies of guarantees for any treatment already carried out. There is evidence for at least partial rebuilding of the north gable end in modern concrete block.

The roofing felt is of a bitumen type, covered with a thin layer of glass fibre batt insulation that is unlikely to be providing much in the way of thermal protection. The felt will also not provide ventilation into the roof void, as there should be in order to prevent the possibility of damaging condensation occurring on the roof timbers or felt itself. A sample of damp meter readings to a selection of roof timbers tested dry on the day of inspection, however, we recommend the roof void is ventilated as part of re-roofing. Not all timbers were visible and given the poor condition of the roof covering some may require replacement as part of works. We had no access to the chimney breast in the loft to test for damp, but in light of the exterior condition of the chimney stack it is almost certain that high moisture levels will be present.

Condition Rating 2.
