LEVEL 3 Your Survey Report

Property Address 42 Any Street
Norwich
NR1 1AA

Inspection date 14 October 1066

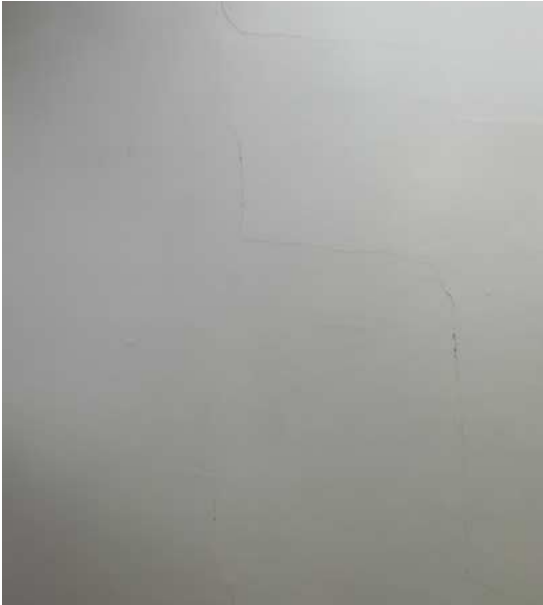
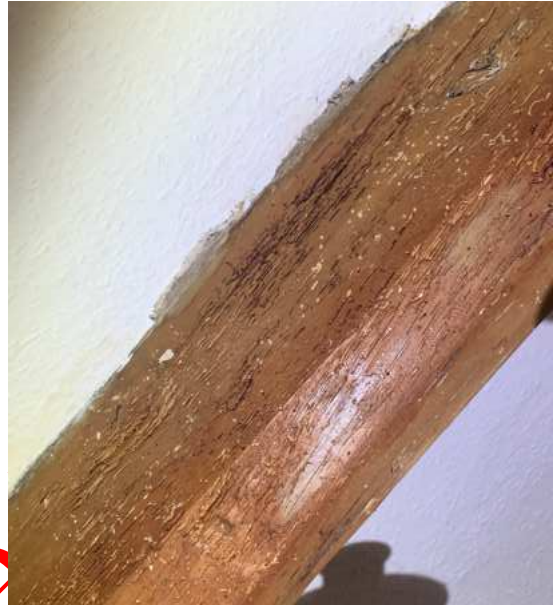
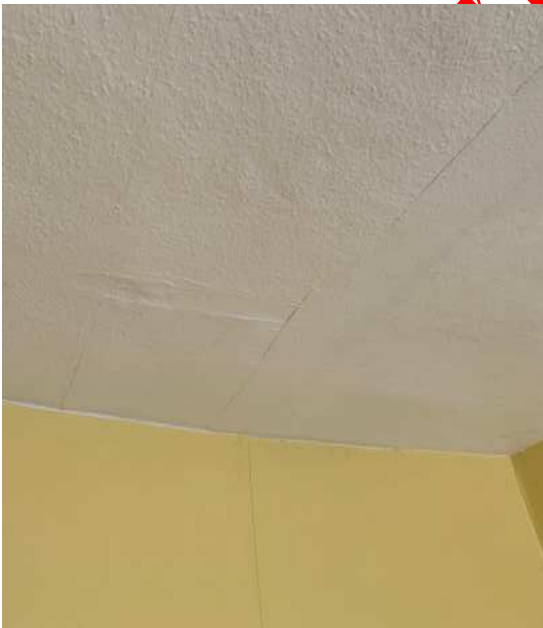
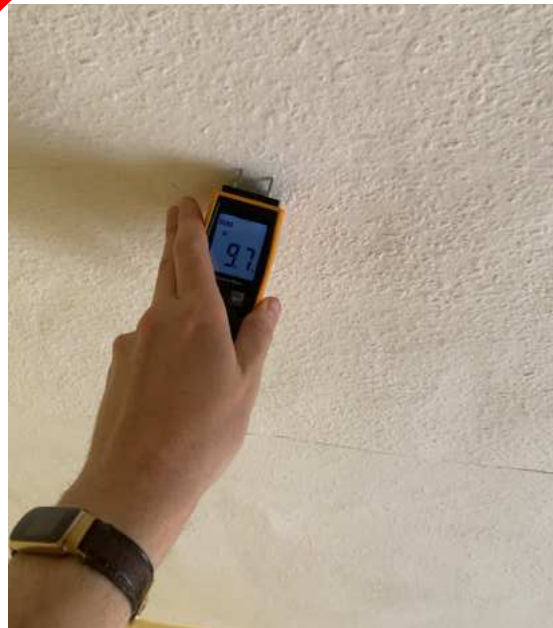
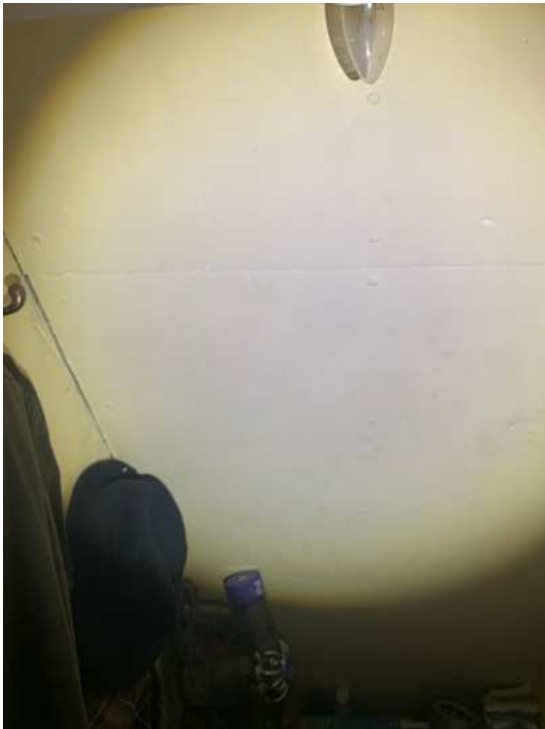
Ceilings comprise painted lath and plaster, textured paper, and areas of exposed timber, with evidence of historic cracks and decorative imperfections consistent with the age and overall condition of the property; they are in average condition throughout. There is evidence of historic woodworm again (see also E1, above, and B – Further Investigations), and evidence for a historic leak in the bathroom, although a sample of damp meter readings in this location tested dry on the day of inspection.

Textured 'wood chip' paper is extremely difficult to remove and it is likely that underlying ceiling will be damaged and require extensive repairs should you choose to do so. The stair soffit is comprised of a material likely to incorporate asbestos cement. Due care and attention should be taken when working with such material and appropriate safety and disposal measures should be in place.

Condition Rating 2.

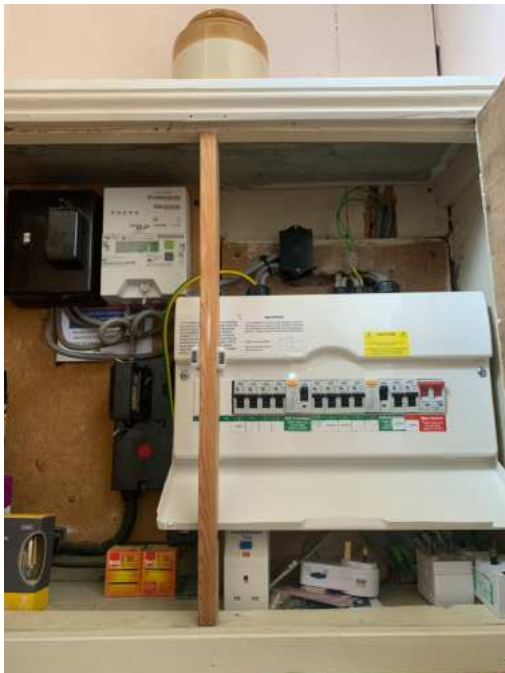
The electricity meter and consumer board are located on the stair soffit. You should ensure that access to these services is kept clear at all times. The electricity supply was on when we inspected.

Condition Rating 3.

Guidelines advise that electrical installations should be tested every 10 years or upon change of ownership or occupation. You are recommended to consider the merits of this advice. You should ask your legal advisor to confirm the validity of any test evidence (see section I). If a recent test certificate, dated within the last 12 months, is not available for the installation, then we recommend it is tested (see section I2).

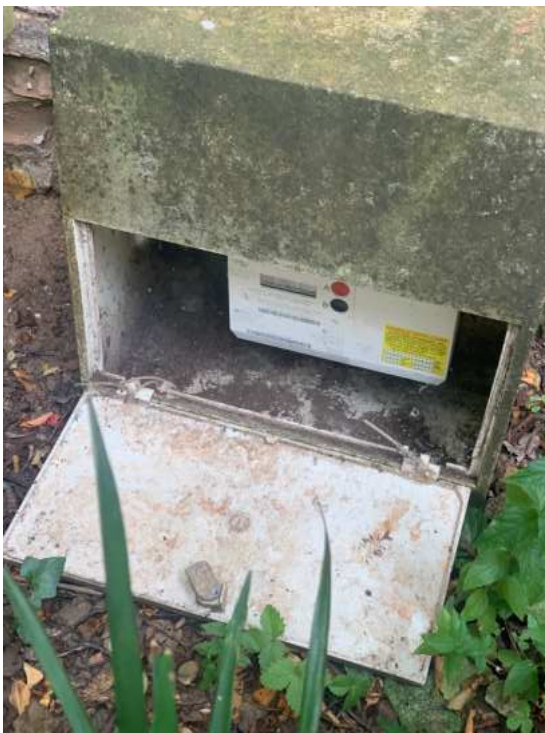
The gas meter and safety valve are located in a cabinet on the north elevation. You should ensure that access to these services is kept clear at all times.

Condition Rating 3.

We have not seen a Gas Safe or OFTEC certificate, your legal advisor should check that there is a Gas Safe / OFTEC certificate and you should ask your legal advisor to confirm the validity of this evidence (see section I). If a recent test certificate dated within the last 12 months is not available for the installation, then we recommend it is tested (see section I2).

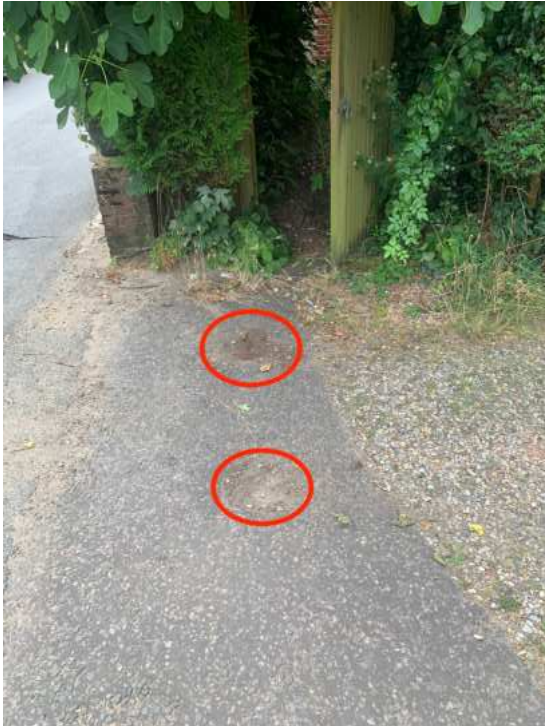
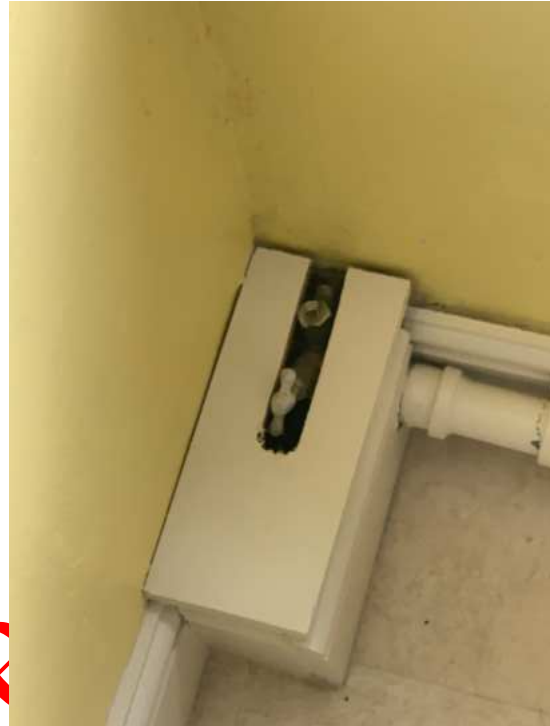
There is a meter and shut off valve on the shared drive at north along with a 2nd that likely serves a neighbouring property (not confirmed); it could not be confirmed which unit serves the subject property. There is an internal stopcock in the 1st floor bathroom.

Condition Rating 3.

Water regulations change regularly and often, and it was not possible to confirm if all the plumbing systems conform to current regulations. We recommend that specific enquiry be made of the vendors through your solicitor to ascertain whether any alterations to the internal plumbing have been made, and if so to check that these were done by qualified and competent contractors. Outside taps should be insulated to prevent freezing in cold weather.

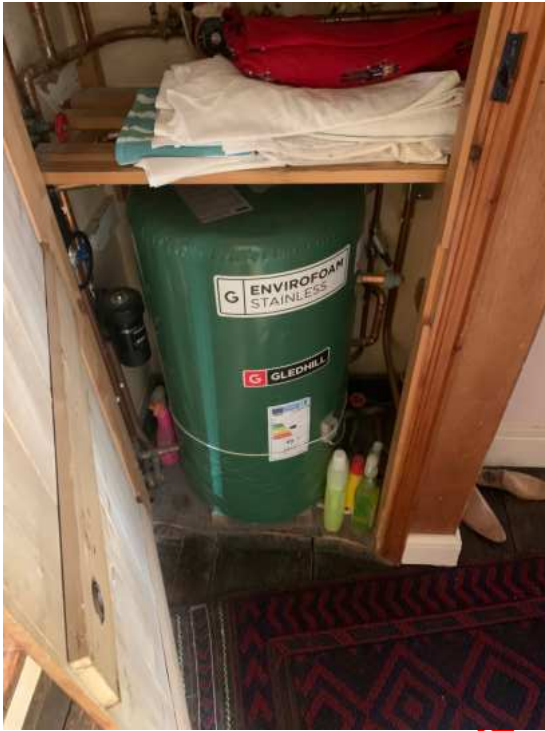
Water heating is provided by an electric immersion heater tank fitted in the 1st floor airing cupboard.

Condition Rating 3.

All heating installations should be installed and serviced regularly (usually every year) by an appropriately qualified person. You should ask your legal advisor to confirm the validity of the safety evidence provided (see section I).

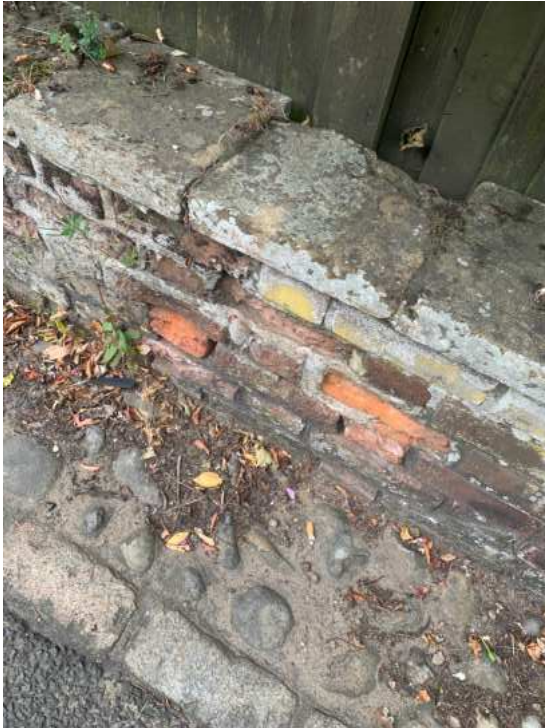
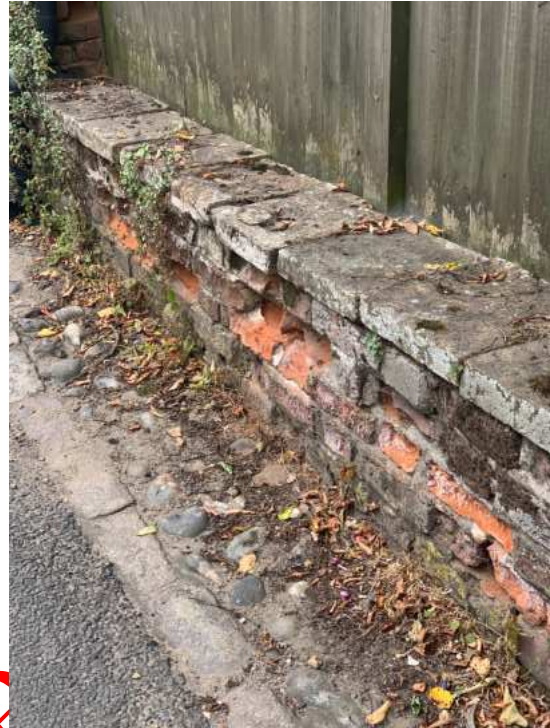
The east boundary's dwarf brick wall is in similarly poor condition to the main walls as described in D4, with significant spalling and pointing failure.

Condition Rating 2.

Your legal advisor should query access rights and maintenance responsibilities for the shared drive at north, and you should also be aware that the property fronts onto the garden of #44 to the south and access arrangements/rights of way should be clarified prior to your making a legal commitment to purchase.
