# Sample Report

## Your Survey Report

Property Address 70 Any Street  
Norwich  
NR1 1AA

Inspection date 14 October 1066

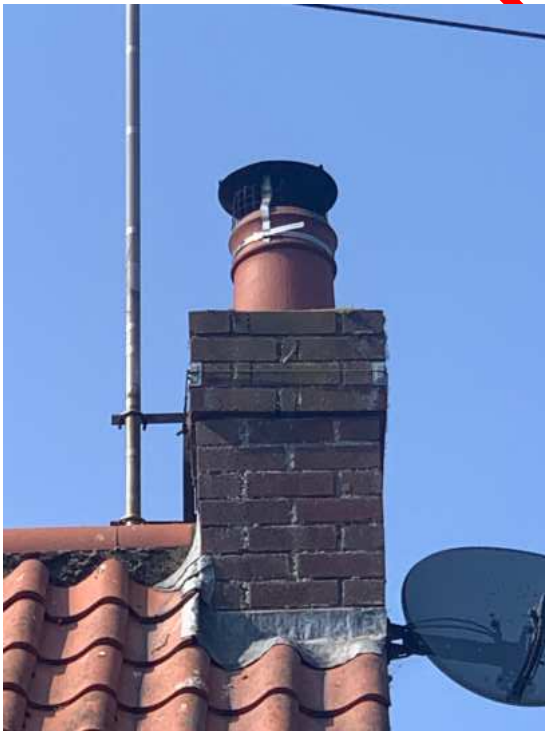
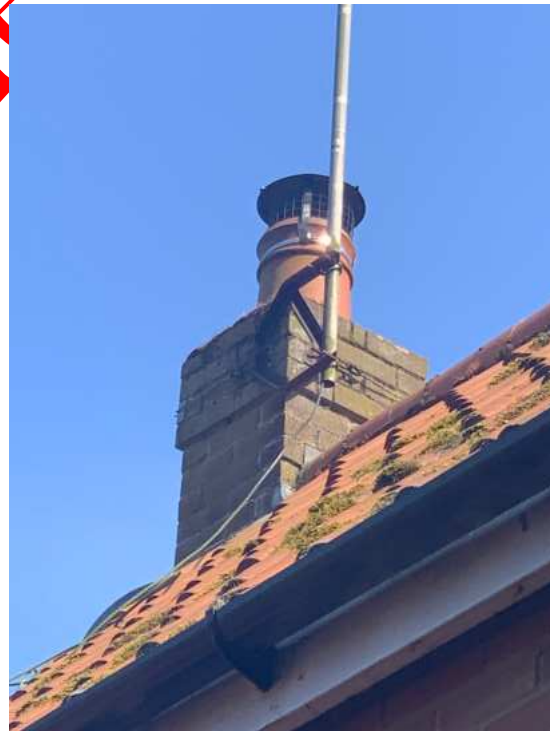
The property has one chimney stack at the east flank. The stack is slightly out of plumb however, not to an extent that we believe warrants immediate rebuilding. It would be prudent to monitor the chimney going forward. Pointing and flashings were in satisfactory condition where visible and there is a single clay pot with cowl. Minor vegetation is visible at the crown which should be cleared in the course of ordinary planned maintenance. Flaunching was not visible. 2

Chimney stacks are particularly exposed to the weather and regular maintenance must be carried out to ensure their stability and weather tightness. Any unused flues should be capped and ventilated internally and externally in order to minimise the risk of damp penetration or condensation build-up within the flues. **Condition Rating 2.**

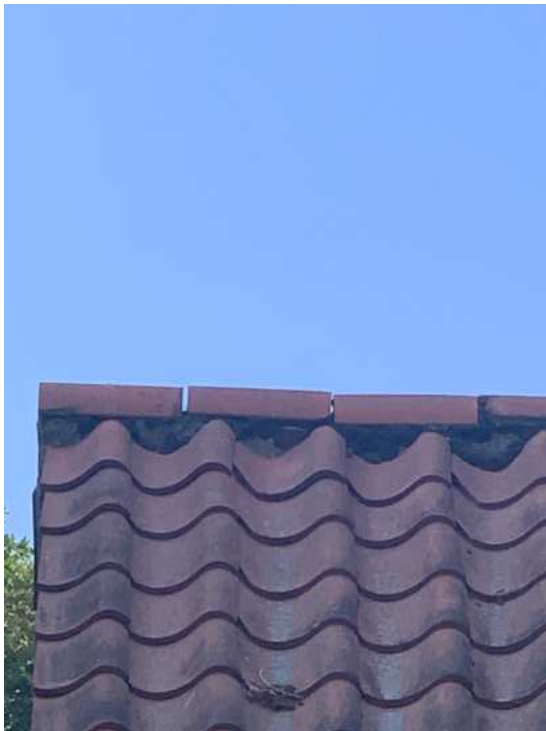
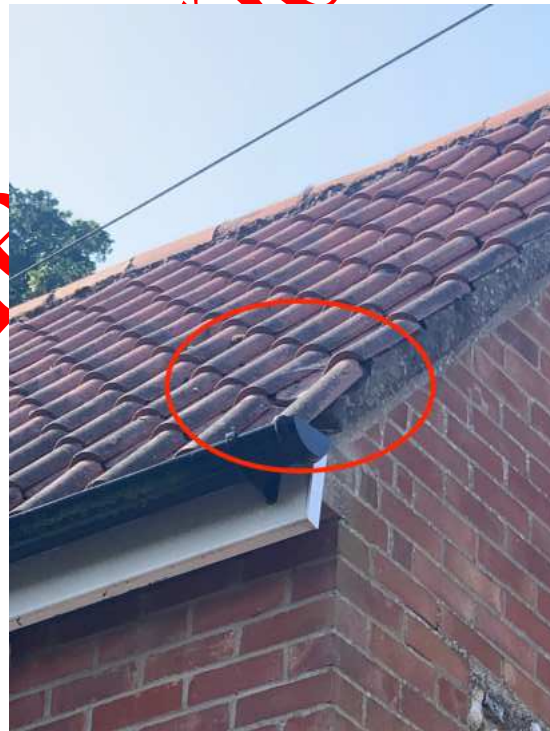
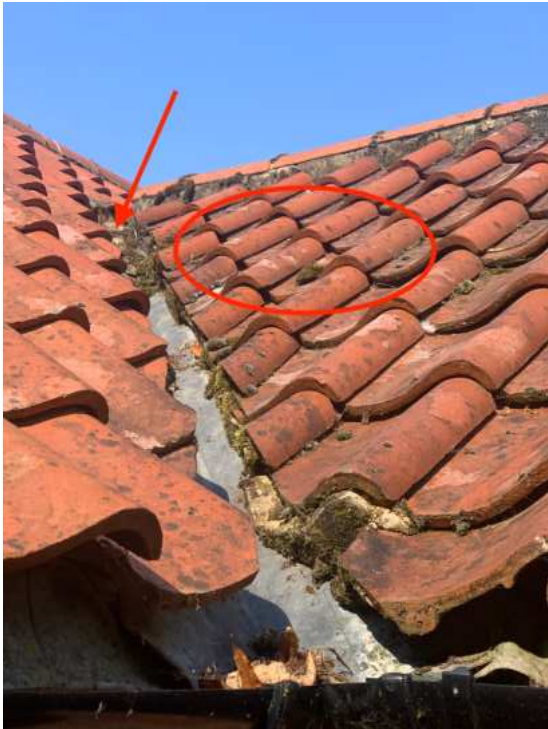
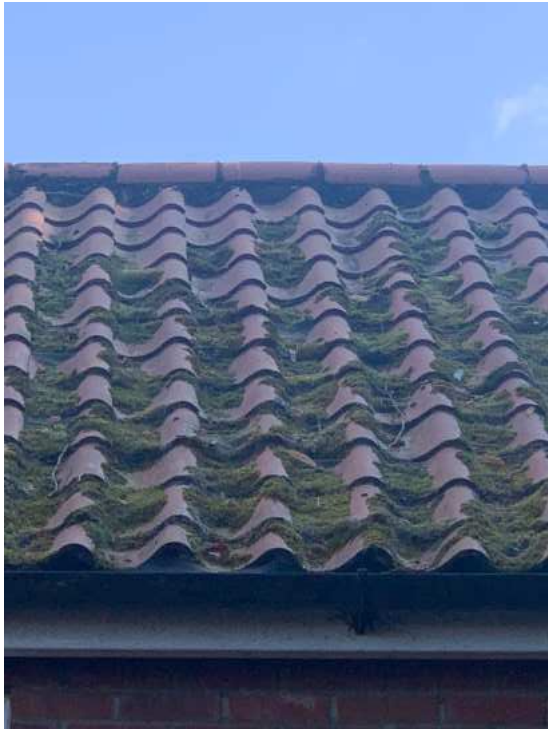
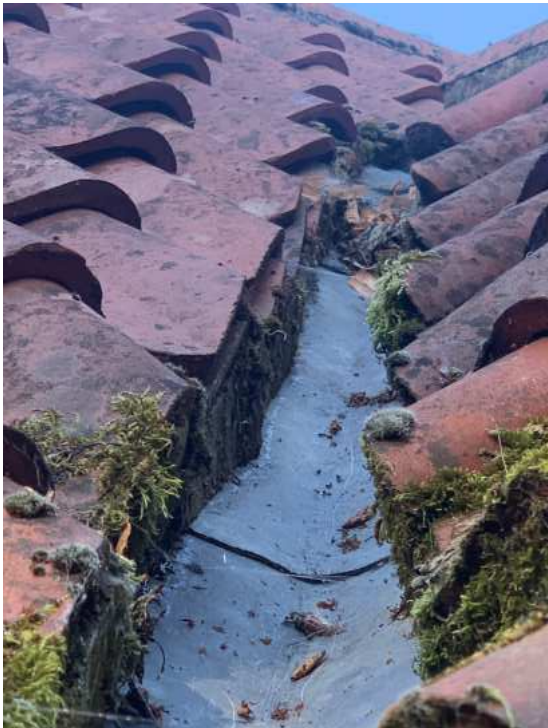
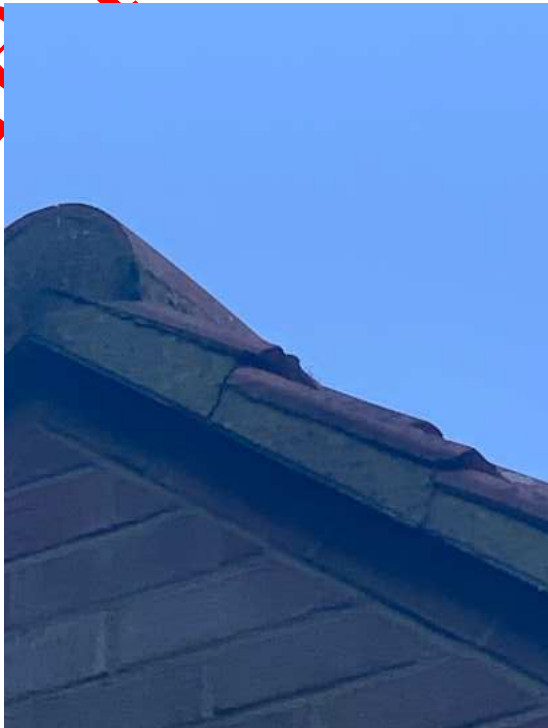
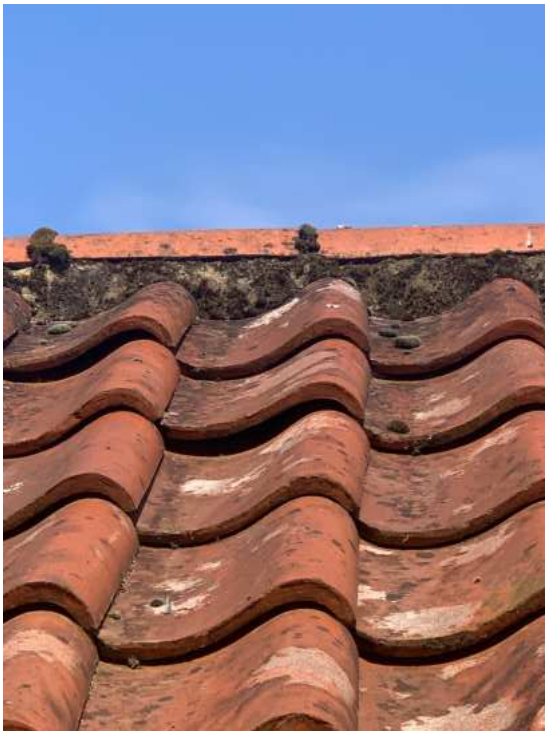
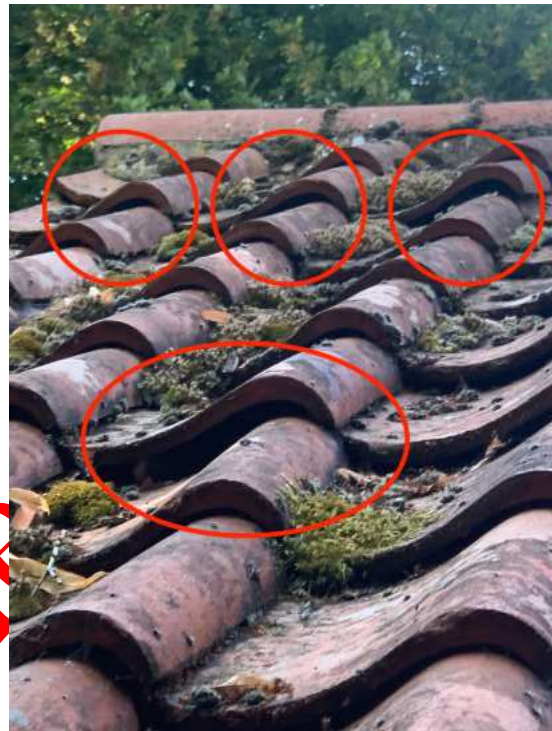
The main roof is pitched and clad in pantile, the main ridge runs from east to west with a link to the converted garage. We noted no visible evidence of structural distortion or splay however, there was slippage of tiles at the eaves and some loose ridge tiles visible. Pantiles generally show poor fit throughout and there is daylight penetrating into loft voids (see E1). There is damage to the valleys as well as debris build-up. Valleys are always potential problem areas and must be regularly inspected and repaired as necessary.

The north roof slopes show some moss and lichen growth, this should be removed periodically as it inhibits roof efficiency and can lead to valley gutters and rainwater goods becoming blocked. We recommend that pointing and bedding to ridge tiles is checked when moss removal is undertaken. The mortar bedding at roof verges, also called a cement fillet, has some minor cracking. The underclanking (tiles underneath the verge pantiles) in the older section of the property are comprised of a material highly likely to contain asbestos cement. According to the Institute for Environment and Health, such asbestos based materials should not be a cause for immediate concern however, should not be drilled or disturbed without taking suitable safety precautions.

We strongly recommend you obtain quotes for recovering the roof in its entirety, and ascertain the costs of these works prior to exchange of contracts. In its present condition the roof covering is highly vulnerable to wind-driven rain or wind lift of tiles, and resultant water ingress. Works to the chimney, roofs, and rainwater goods can be attended to at the same time to economise on enabling works (e.g. scaffolding, skip hire, etc...).

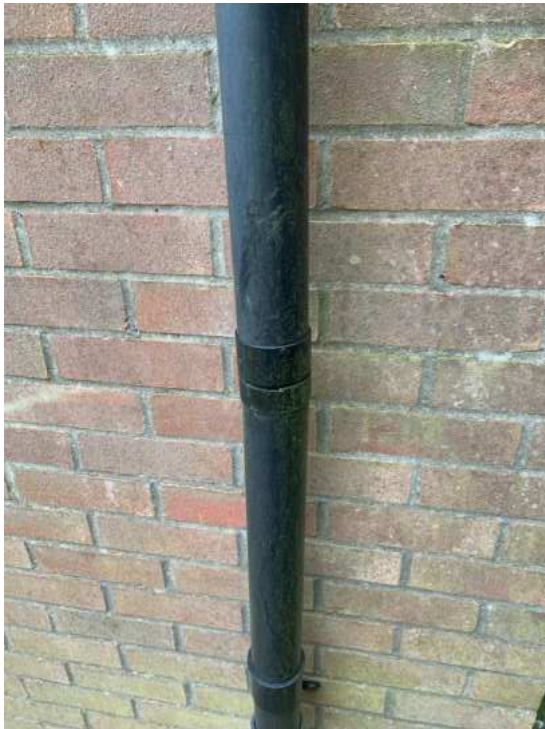
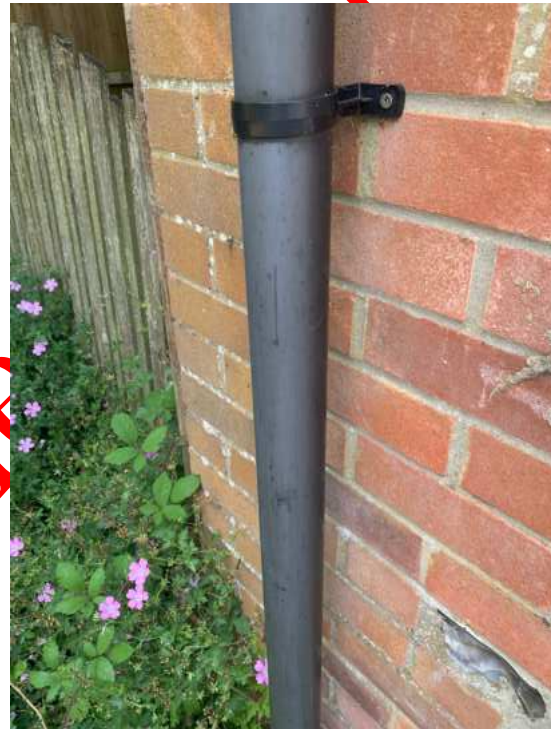
The rainwater goods are made of PVC and are in broadly satisfactory condition. However, there are blockages visible (see also roof valleys, D2 above) and some gutter brackets at the rear are missing. There is some fading and brittleness to downpipes on the front elevation due to weathering from their southerly aspect. We recommend that the guttering and rainwater goods is due minor attention now. A video file of relevant defects will be provided along with the PDF copy of this report.

Gutters should be cleaned on a regular basis to avoid blockage, which can lead to water overflow onto wall surfaces and clogged downpipes. Rainwater harvesting tanks, if present, were not inspected in detail.

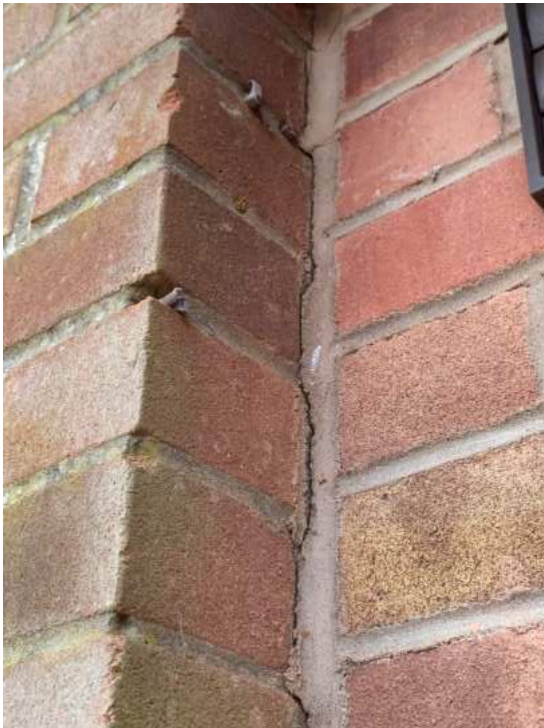
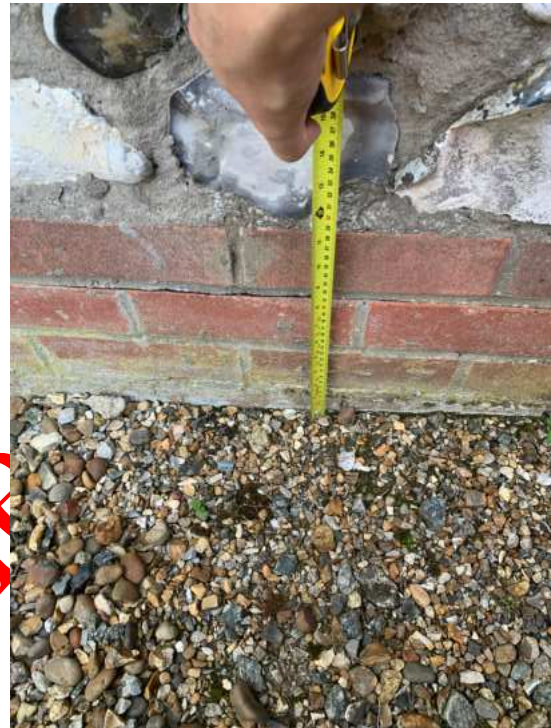
The main walls are of brick faced cavity masonry with the bricks laid in stretcher bond (one-over-two) with flint dressings. There are some very minor hairline cracks at the east elevation and the junction between the original portion of the house and the extension however, pointing is in generally good condition throughout. The damp proof course (DPC) is comprised of plastic and is fitted at least 150mm above the external landscaping which is consistent with good practice. We noted no signs of structural movement externally.

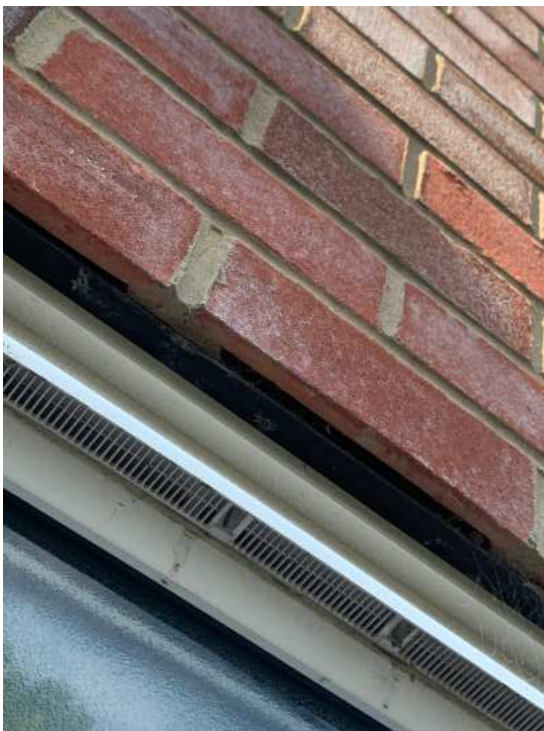
The windows are PVC double glazed units and appear to be in generally good condition. There were no visible gaps to edge seals and no damage to the sills. We noted no misting between the panes in the double glazing. There is a single window head at the ground floor south east (front of garage conversion) where the lintel/head is unfinished. We recommend that this is undertaken as part of planned maintenance in order to ensure continued weathertightness of the unit. A sample of windows was tested and these opened and closed cleanly.

New regulation came into effect in 2002 and double-glazed windows fitted after that date must either be installed by qualified contractors (FENSA registered) or alternatively the subject of building regulation approval obtained at the time of installation. Your legal advisor should request certification.

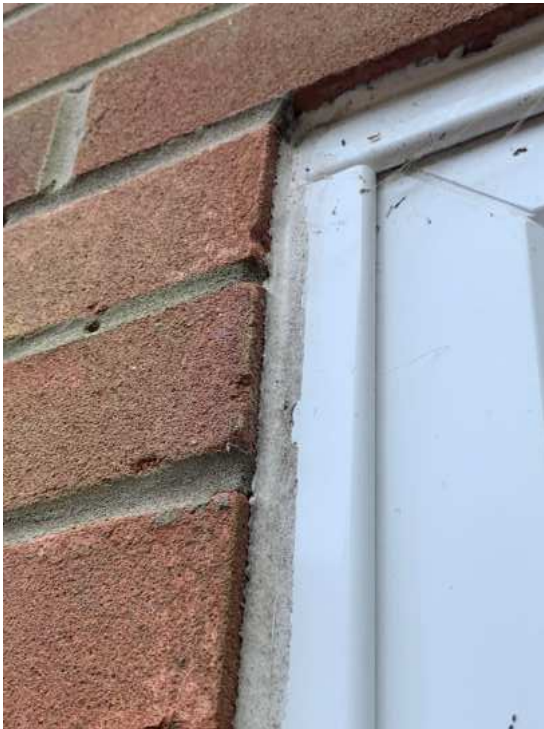
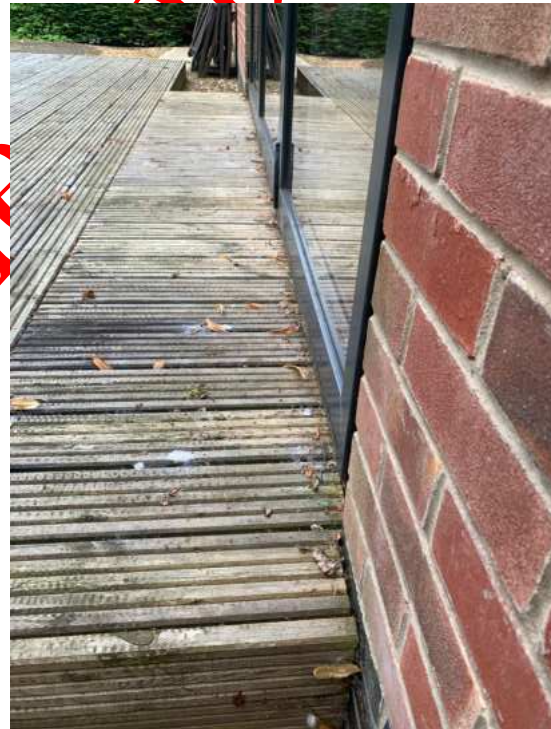
The front door is a PVC framed wood effect unit with double glazed vision panel. It appears to be in generally satisfactory condition. We noted no evidence of misting between the double glazing panes and edge seals and sill are in satisfactory condition also. The door opened, closed and locked cleanly.

The rear kitchen door is also a PVC framed double glazed unit with a double glazed side light. The edge seals appeared to be approaching the end of their serviceable life and may benefit from replacement as part of their next planned maintenance cycle. We noted no misting between the double glazing panes and the sill was intact and in good order. This door opened, closed and locked cleanly also.

The rear sitting room doors are a set of aluminium double glazed bi-folds with again no misting between double glazing panes visible. Edge seals are in generally satisfactory condition and the doors opened, closed and locked cleanly. There is a flush threshold between the sitting room interior and the rear decking, although this is not in itself an issue flush thresholds can allow water ingress and also the proximity of the decking to the channel drain at the base of the doors may lead to the decking rotting over time and we do recommend you monitor this area.

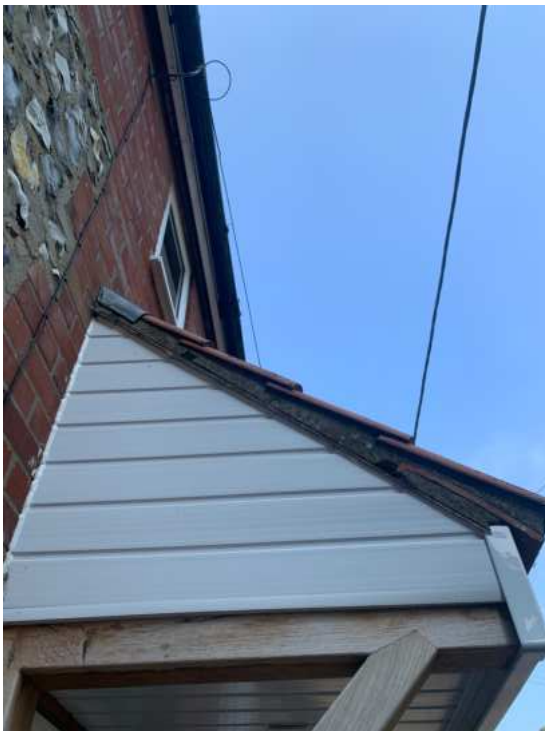
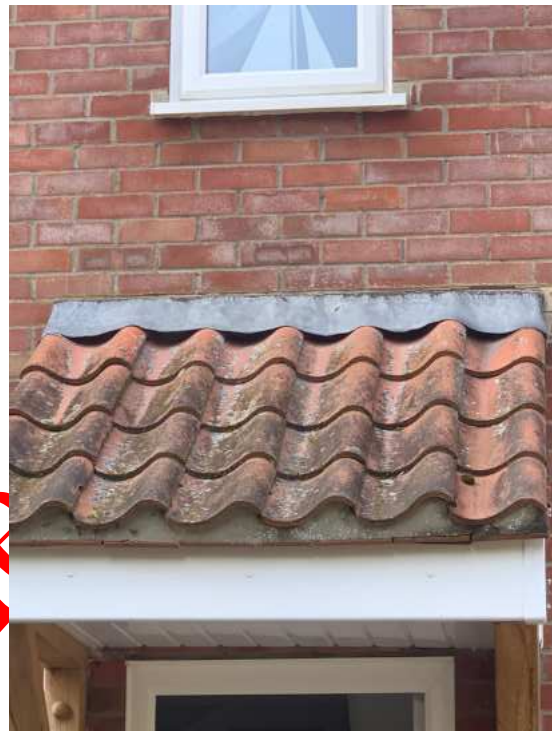
The property has a small timber framed porch with pantile roof at the front. The roof verges are exhibiting some signs of cracking and should be monitored and repaired if this worsens. Some of the lead flashing has gappy fit and may allow wind driven rain to enter. The timber brace on the right hand side poses a hazard to taller occupiers and visitors as it is at head height on the approach to the front door.

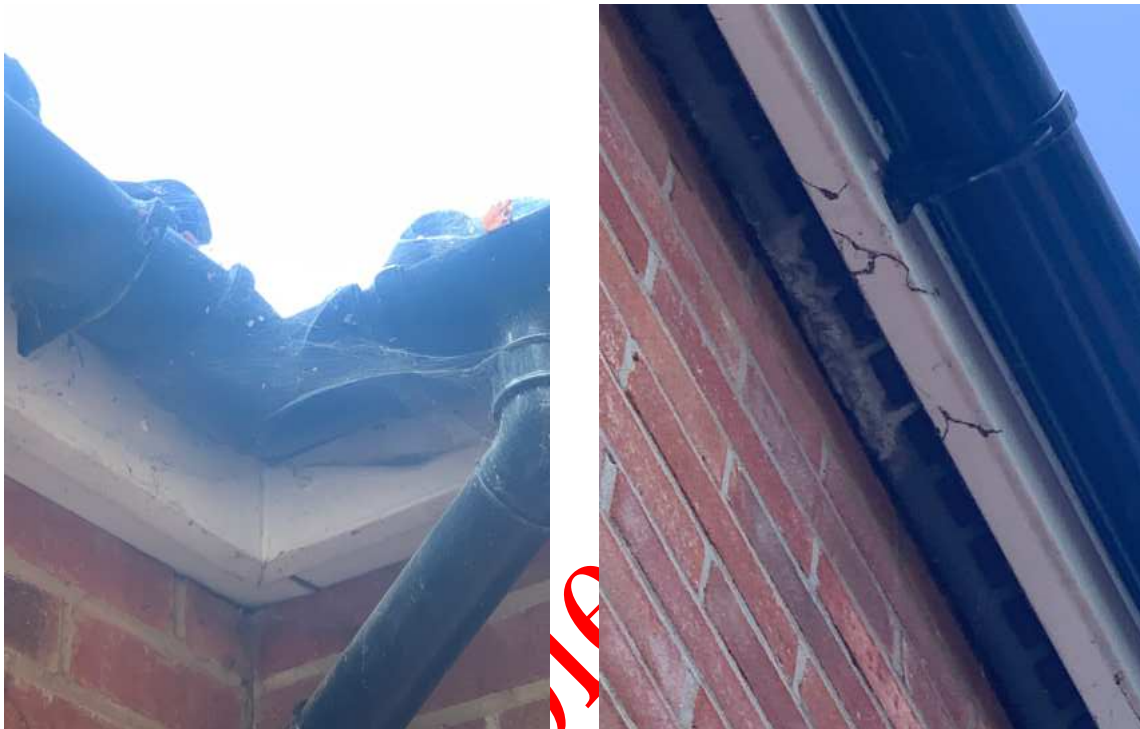
The property is fitted with PVC fascias and PVC vented soffits, all of which are in generally satisfactory condition however, would benefit from a thorough cleaning. The soffit vents provide ventilation into the loft void and should be kept clear of debris.

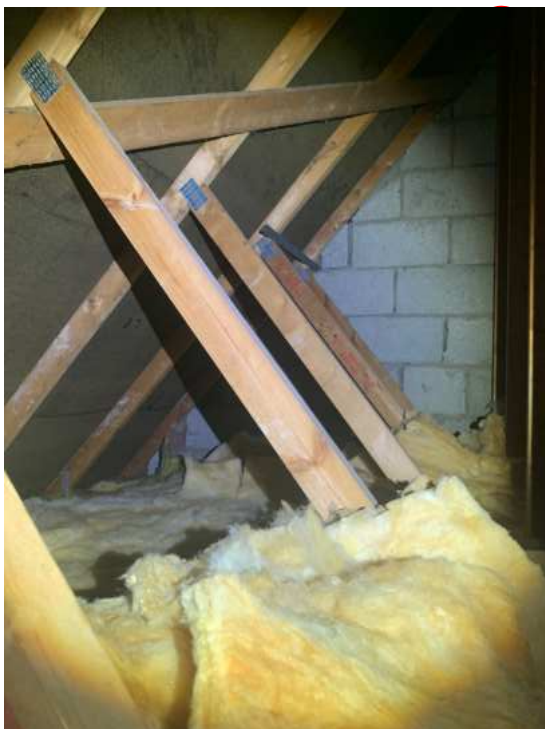
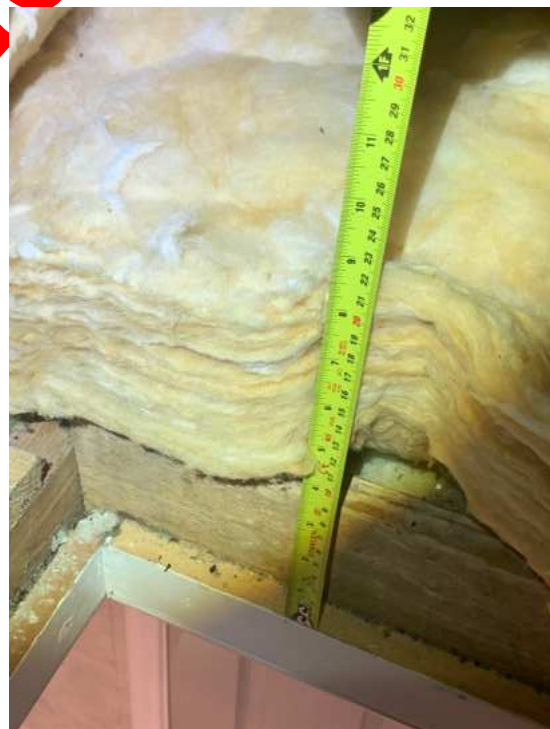
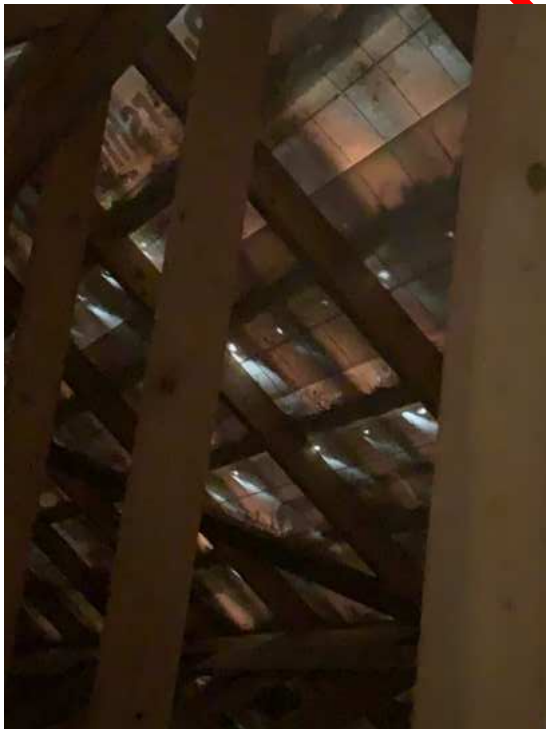
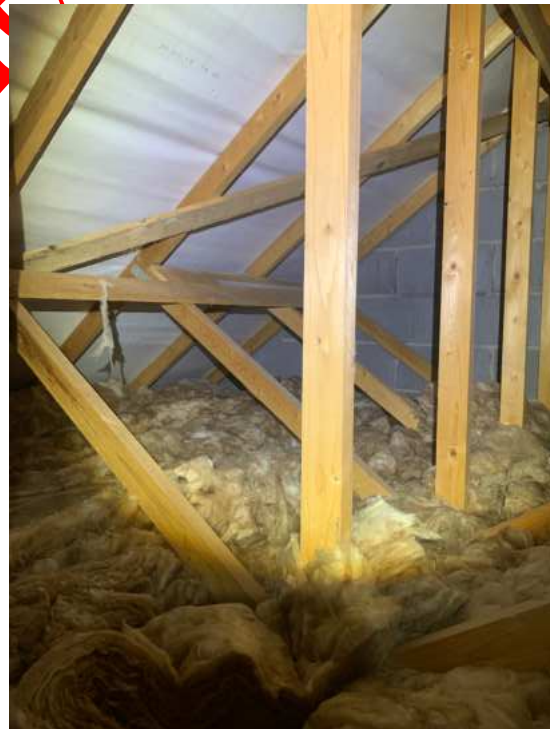
The main roof structure is comprised of lightweight prefabricated timber truss typical for a house of this type and age. There is no loft ladder and no light in the roof space. We noted no evidence of structural distortion or splay to the roof timbers and no evidence of insects or vermin. The roofing felt is of an older bitumen type although this is in generally satisfactory condition with no holes or tears visible. This type of roofing felt will not provide ventilation into the loft void however, this is provided by vented soffits, these should be kept clear to prevent damaging condensation from building up on the roof timbers or on the roofing felt itself. There is glass fibre batt insulation present to a depth of approximately 200mm, the insulation is evenly distributed and undisturbed and should remain in place to maximise its thermal efficiency. Masonry at the west gable end was in satisfactory condition where visible and a sample of damp meter readings to a selection of roof timbers all tested dry.

The roof space over the east garage bedroom and en-suite is also comprised of prefabricated lightweight timber truss however, this is fitted with a modern breathable roofing felt which will allow ventilation into the loft void and thus prevent damaging condensation from occurring on the roof timbers or on the felt itself. Gaps and poor fit to tile covering (see D2) are very noticeable in this area. We noted no evidence of structural distortion or splay in these roof timbers either and the roofing felt was in good condition. There is mineral wool insulation to a depth of approximately 300mm and again insulation batts are undisturbed and evenly distributed. The east gable end masonry was in satisfactory condition where visible and a sample of damp meter readings on a selection of roof timbers tested dry.

The roof structure and loft areas appear generally sound as of the date of inspection, however, given the condition of the roof coverings the space is vulnerable to water ingress, and you should obtain quotes for recovering the roofs in their entirety; costs should be ascertained prior to exchange of contracts.

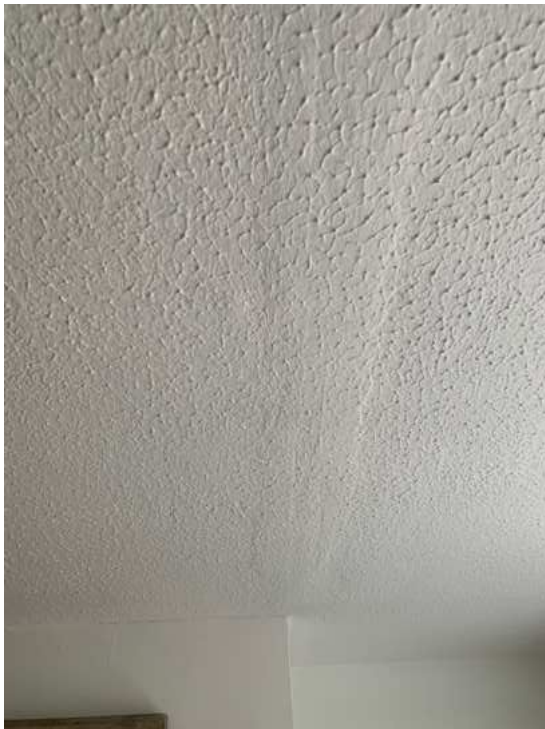
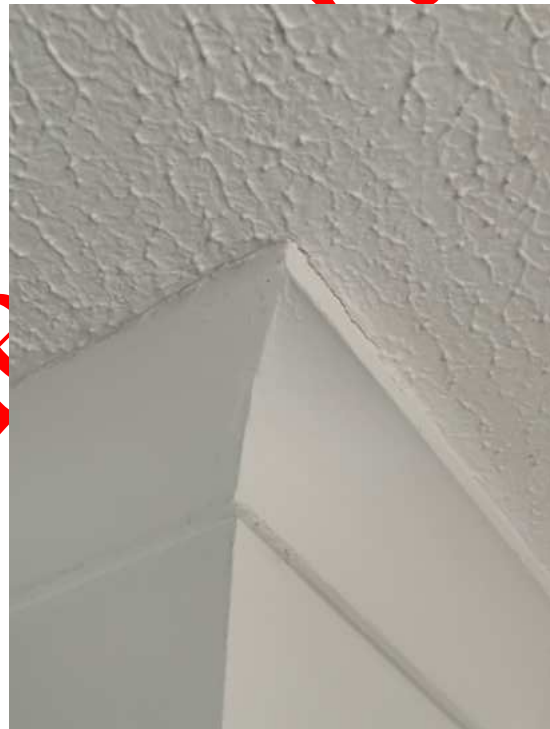
The ceilings are predominantly skim plastered and painted, they appear to be newly decorated and are in generally good condition throughout. There are some areas of textured plaster in the older section of the property exhibiting hairline cracking and decorative imperfections consistent with the age and the overall condition. Where ceilings have been provided with a textured artex type finish it should be noted that such coatings applied prior to 1984 can incorporate an asbestos content and due care and attention should be taken when working with such materials.

There are polystyrene covings fitted in the older section of the property. Polystyrene finishes are a safety hazard because they are highly flammable and give off poisonous fumes in a fire. These should be removed now. Removal may damage the walls and ceilings underneath, requiring more extensive redecoration or repair.

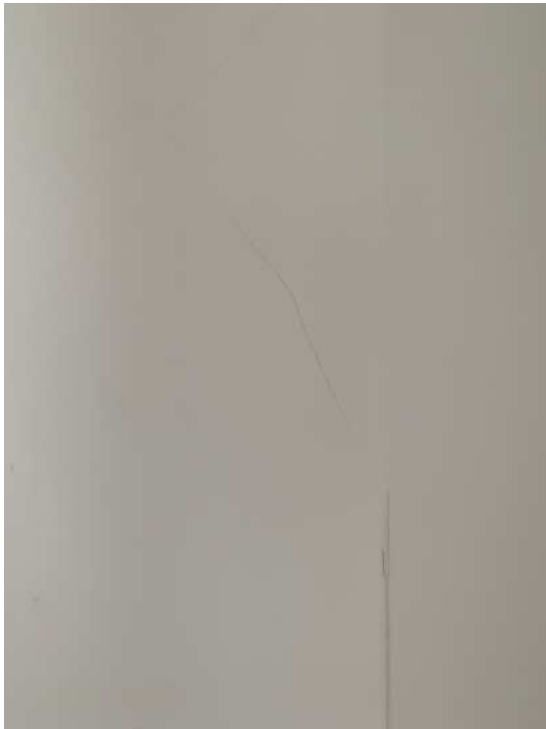
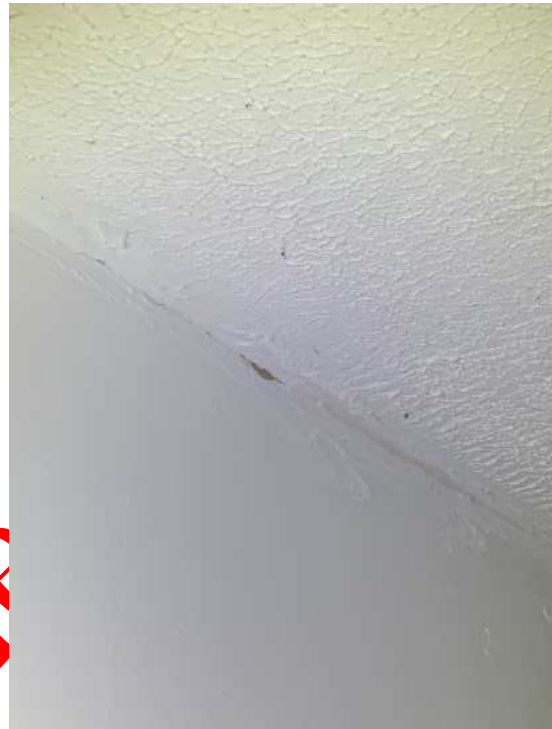
The internal walls are of painted skim plaster finish and are in generally satisfactory condition throughout. They exhibit minor shrinkage and decorative cracking commensurate with the age and overall condition of the property. We noted no evidence for structural movement or moisture penetration internally and all sample damp meter readings to the perimeter walls at ground floor level tested dry.

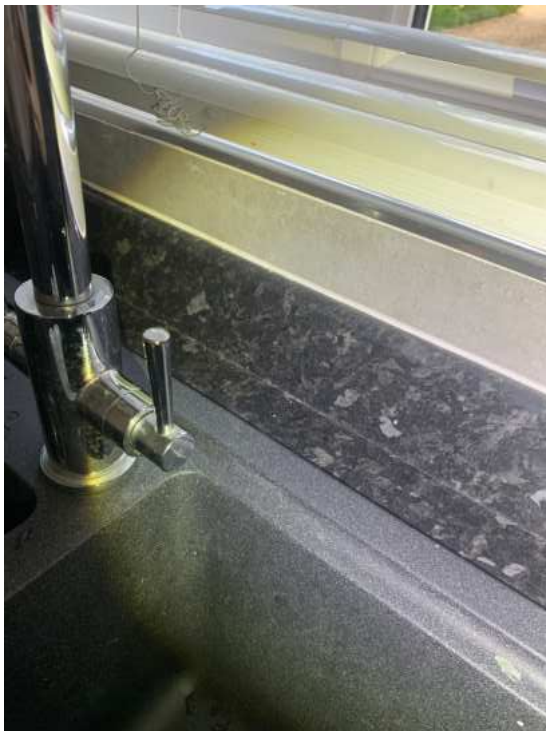
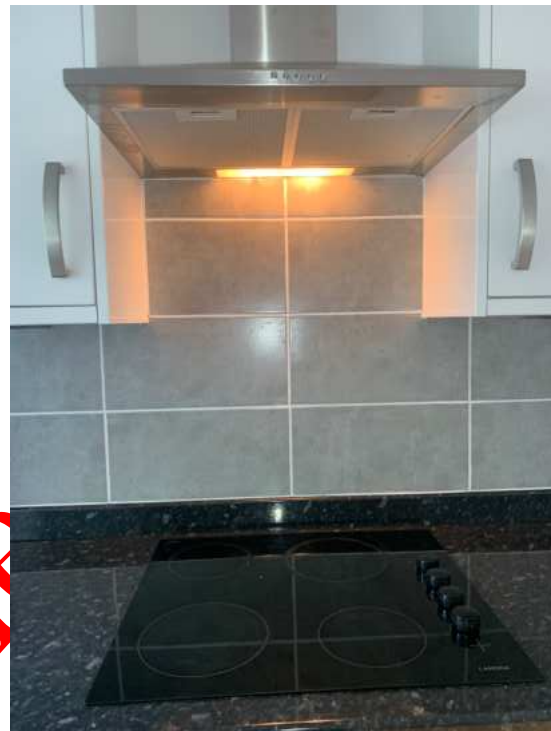
The kitchen is fitted with built-in fittings that are modern and in generally satisfactory condition. Sealants between the kitchen worktops and splashbacks appeared to be in good condition also. However, these should be monitored for degradation and kept clean as their failure can result in damp ingress and wood rot. There is mechanical ventilation present which was functioning correctly during our inspection.

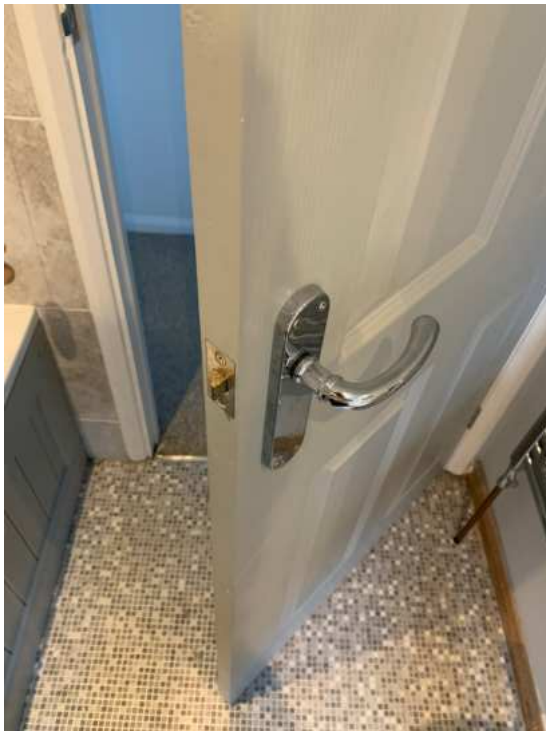
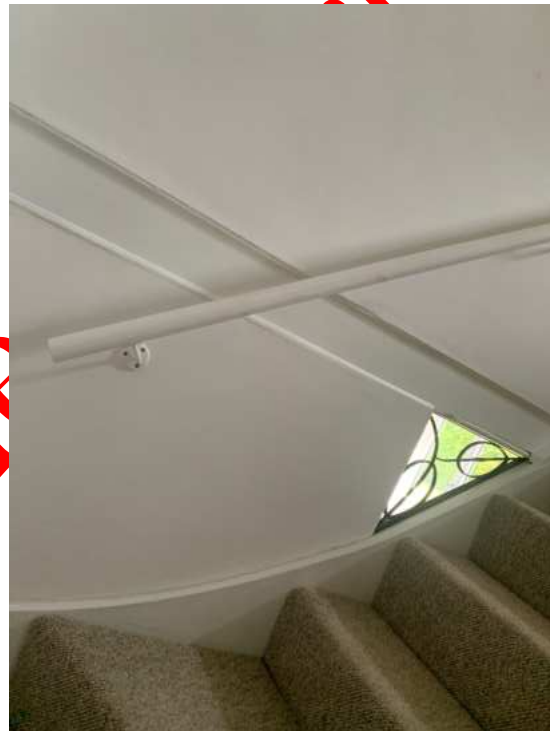
The stairs and handrails are solid and firmly fixed with no evidence of major gaps or movement. Handrails are fixed at the correct height and the pitch of the stairs is comfortable. On the whole, the stairs are in satisfactory condition.

Fitted wardrobes and storage units, where present, were in satisfactory condition generally and a sample of their doors opened and closed cleanly.

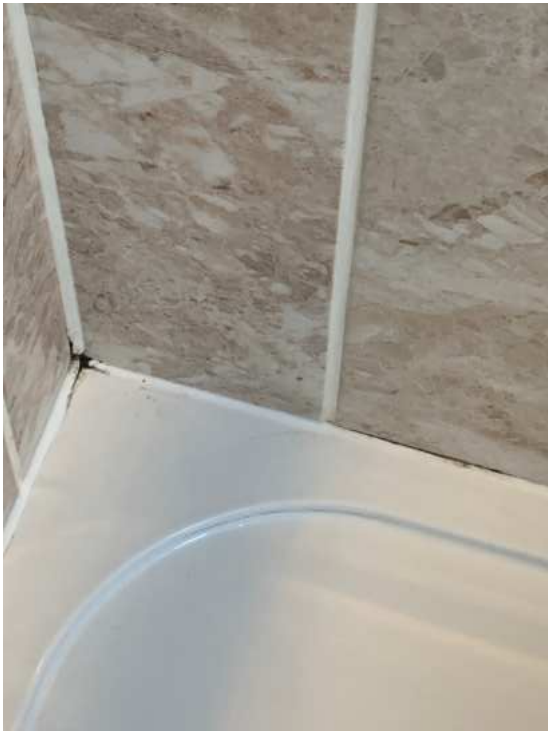
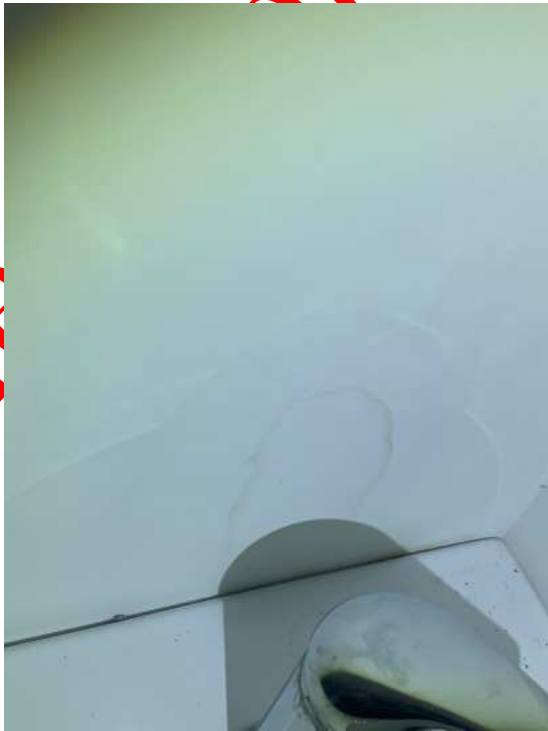
The first floor bathroom, ground floor en-suite and ground floor WC are all fitted with modern sanitaryware and are in generally good condition. The sealants around the edges of sanitaryware were in generally satisfactory condition however, there is minor black mould build-up in the ground floor en-suite and no flexible sealants around the sink of the ground floor WC. Flexible sealants are important and should be monitored and kept clean as they can leak and damage adjacent surfaces. Where not installed or if not repaired quickly wood rot can soon develop. The ground floor en-suite is fitted with mechanical ventilation however, there is no mechanical ventilation in the first floor bathroom. We recommend the installation of an extractor fan to provide effective means of managing condensation and bathroom odours. There is evidence of historic splash damage in the ground floor WC (behind the hand wash basin) however, a sample of damp meter readings in this area tested dry on the day of inspection. You may wish to install a splashback to prevent further issues.

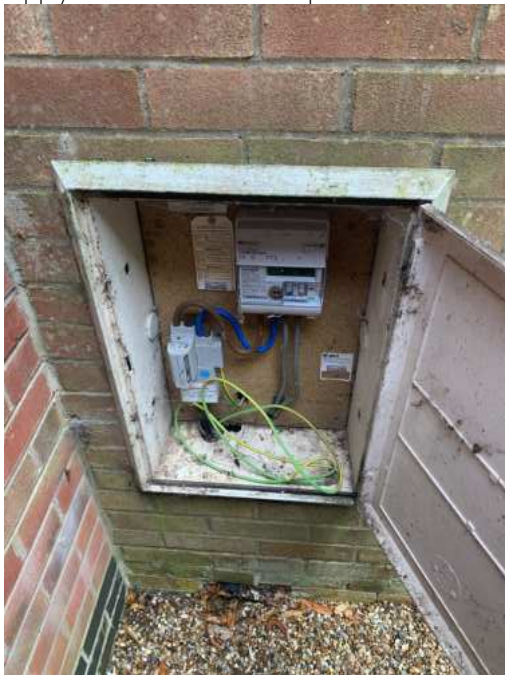
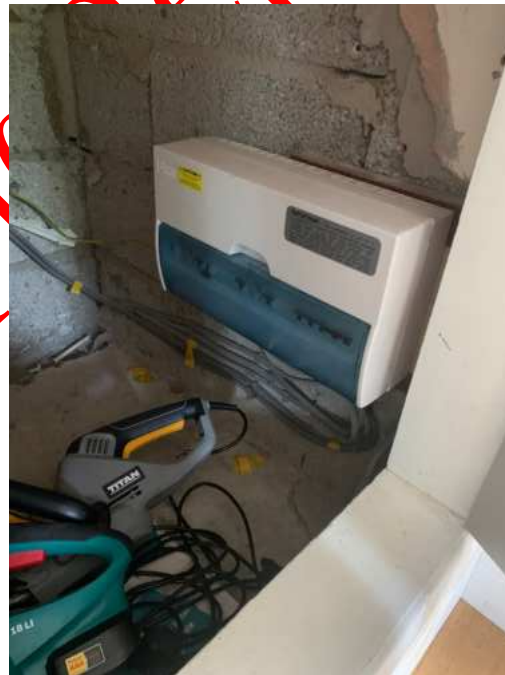
The electricity meter is located on the rear elevation near the back door. The consumer board is located under the stairs. You should ensure that access to these services is kept clear of all times. The electricity supply was on when we inspected.

Guidelines advise that electrical installations should be tested every 10 years or upon change of ownership or occupation. You are recommended to consider the merits of this advice. You should ask your legal advisor to confirm the validity of any test evidence (see section I). If a recent test certificate, dated within the last 12 months, is not available for the installation, then we recommend it is tested (see section I2). **Condition Rating 3.**

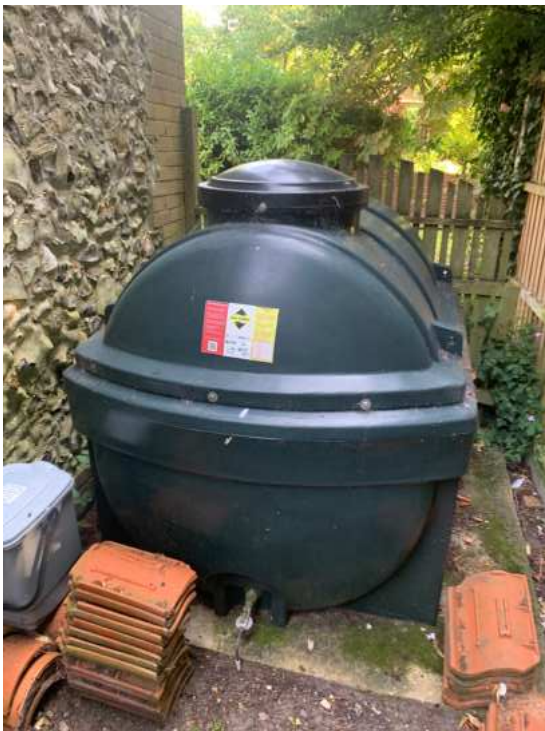
The property is fitted with an oil tank in the blind passage at the west.

We have not seen a Gas Safe or OFTEC certificate, your legal advisor should check that there is a Gas Safe /OFTEC certificate and you should ask your legal advisor to confirm the validity of this evidence (see section I). If a recent test certificate dated within the last 12 months is not available for the installation, then we recommend it is tested (see section I2).

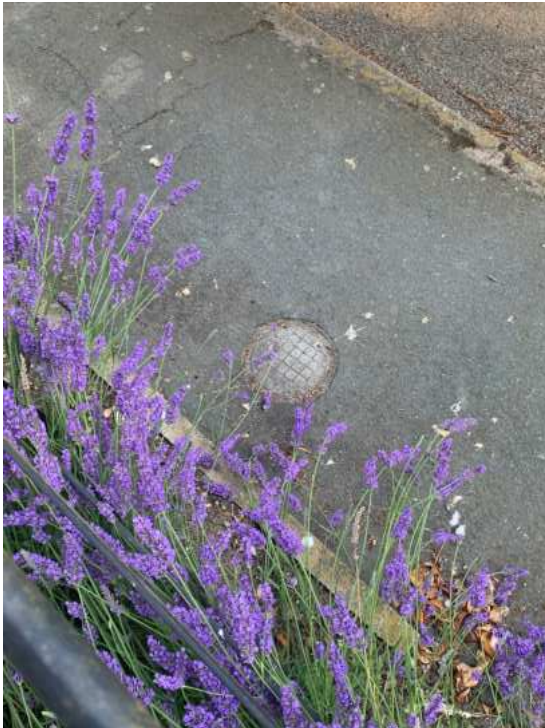
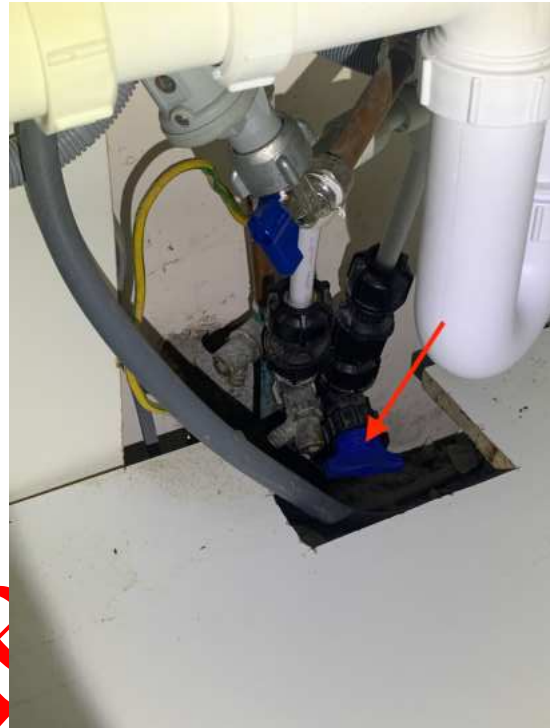
The water meter/shut-off valve is located in the pavement to the front of the property. There is an internal stopcock located underneath the kitchen sink. A sample of sanitaryware was tested and water pressure was found to be satisfactory on the day of inspection.

Water regulations change regularly and often, and it was not possible to confirm if all the plumbing systems conform to current regulations. We recommend that specific enquiry be made of the vendors through your solicitor to ascertain whether any alterations to the internal plumbing have been made, and if so to check that these were done by qualified and competent contractors. Outside taps should be insulated to prevent freezing in cold weather.

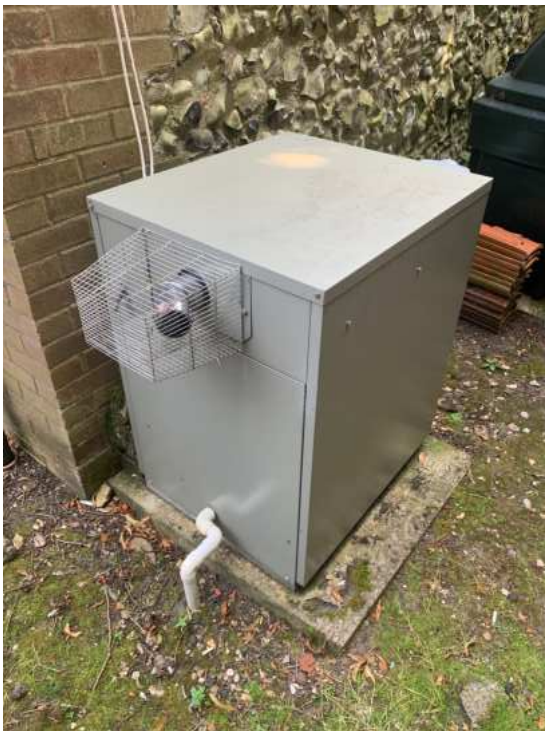
We were unable to verify the output of the boiler and no calculations have been made to verify its adequacy. Furthermore, we were unable to verify if the boiler is correctly ventilated in accordance with current regulations.

We noted no evidence of weep leaks or damage to the radiators. These should be monitored after a period of inactivity as upon refiring it is possible that leaks at radiator joints may occur from contraction/expansion of components.

All heating installations should be installed and serviced regularly (usually every year) by an appropriately qualified person. You should ask your legal advisor to confirm the validity of the gas/oil safety evidence provided (see section I).

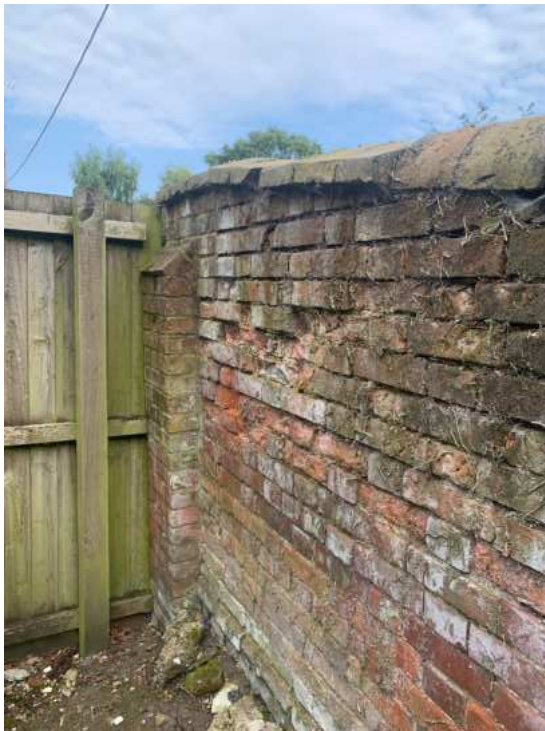
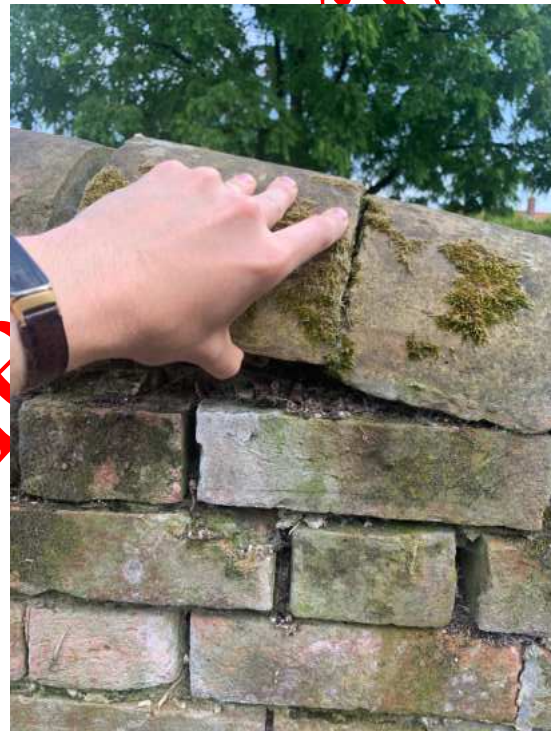
The east front garden wall is in extremely poor condition and shows evidence for structural movement. There are considerable sections of loose masonry and the wall can be easily moved by hand. A video file of this defect will be provided to you along with the PDF copy of this report. In its present condition, the wall poses a serious hazard and you are advised to obtain quotations for its repair urgently. If sections of masonry were to fall onto the public highway or injure passersby you, as the property owner, could be found liable.

Other boundaries appeared to be in generally satisfactory condition as did the decking at the rear, however, we refer you back to our note about the flush threshold in Section D6, above. The east passage gate was generally operational however, the locking mechanism is loose.

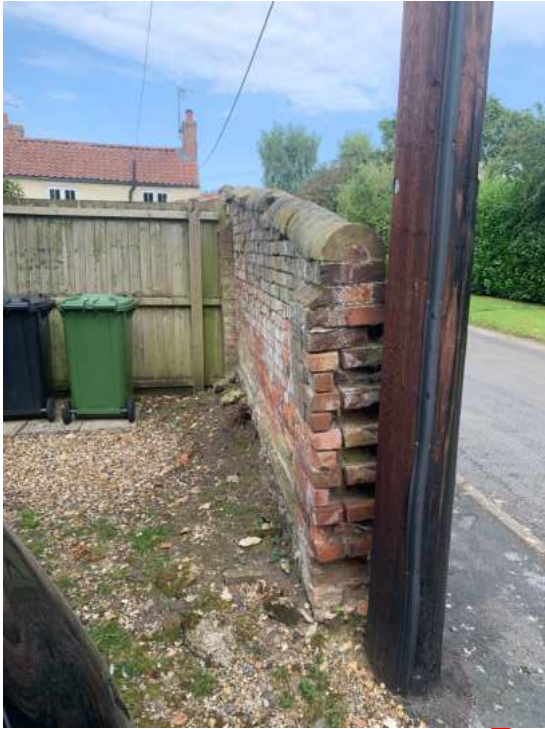
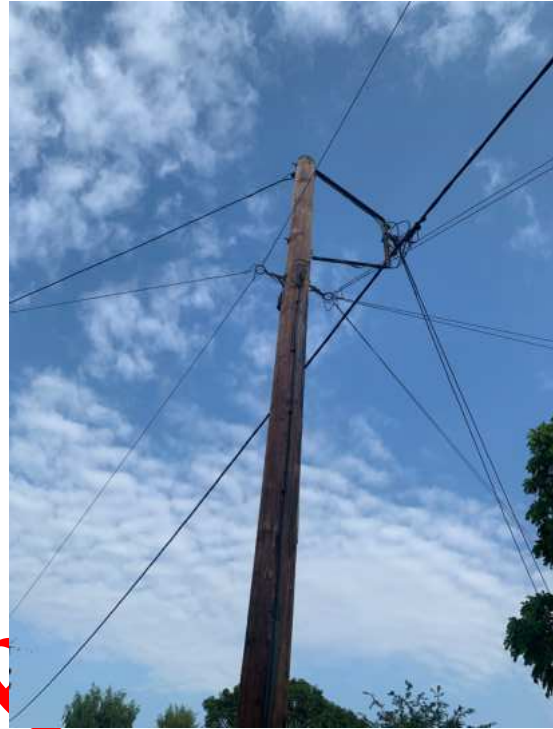
There is a utility pole and its guy wires, as well as over-sailing cables at the front boundary. Your legal advisor should query any rights of way or easements in favour of utility companies as well as any access requirements for maintenance of this equipment as they may pose a nuisance.
