LEVEL 3 Your Survey Report

Property Address 42 Any Street
Norwich
NR1 1AA

Inspection date 14 October 1066

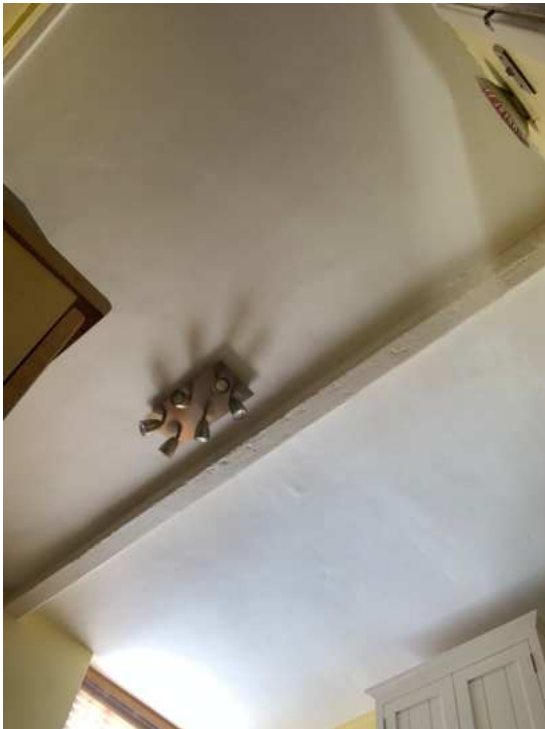
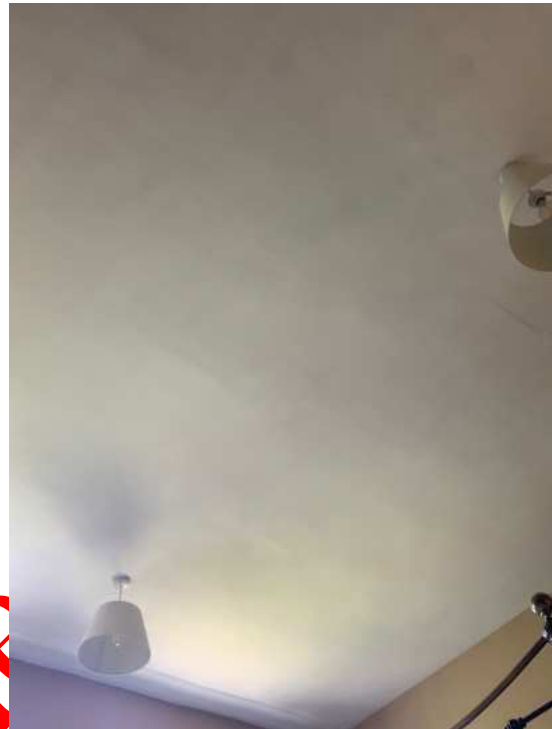
The property is not fitted with a heat detector in the kitchen nor with smoke detectors in the bedrooms, and the doors are not FD30 fire rated. You are advised to consider the installation of a comprehensive smoke / heat detection system to LD3 standard under BS 5839 Pt 6: 2019 with heat detector in the kitchens and smoke detection in the living rooms and all bedrooms.

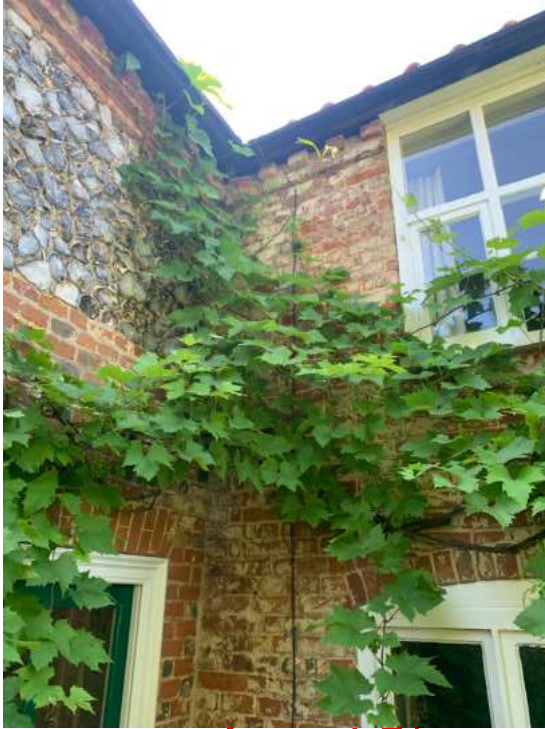
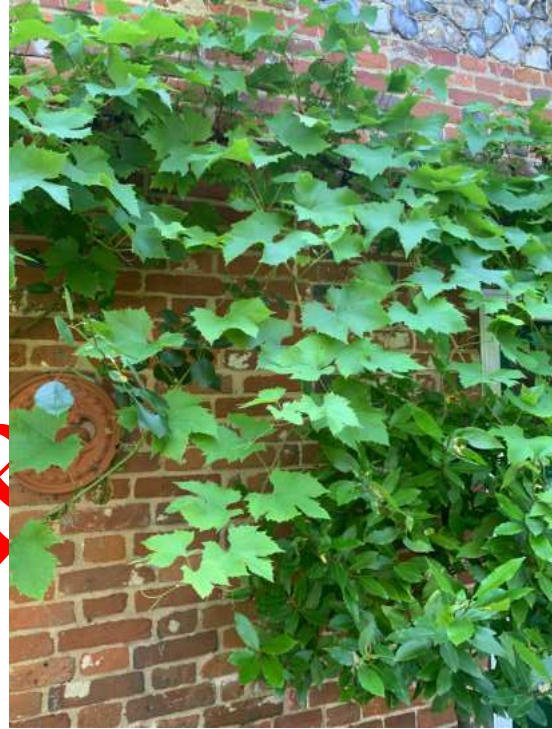
Large portions of the rear walls were covered in climbing plants and our inspection was therefore limited. Also access to the south elevation of the property is demised through the garden of #44, which could not be accessed. The south elevation was therefore inspected only from the public highway.

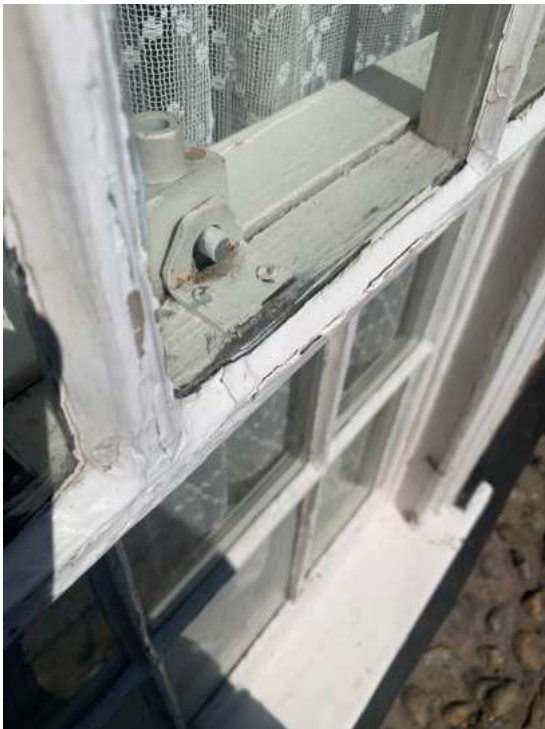
Condensation may be encountered during the course of normal occupancy. If not managed correctly, condensation can lead to mould growth, which can have adverse health effects. Maintaining a reasonable balance between heating, ventilation, and insulation should prevent excessive condensation build-up. This may require a review of your lifestyle and occupancy of the building (e.g. opening windows, heating intervals, and use of appliances such as tumble dryers). There are no trickle vents and therefore no means of providing passive ventilation, which is critical in solid-walled properties.

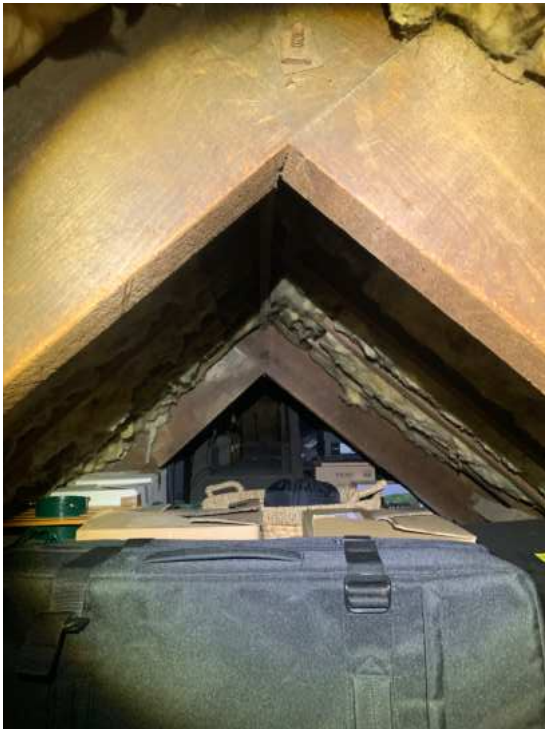
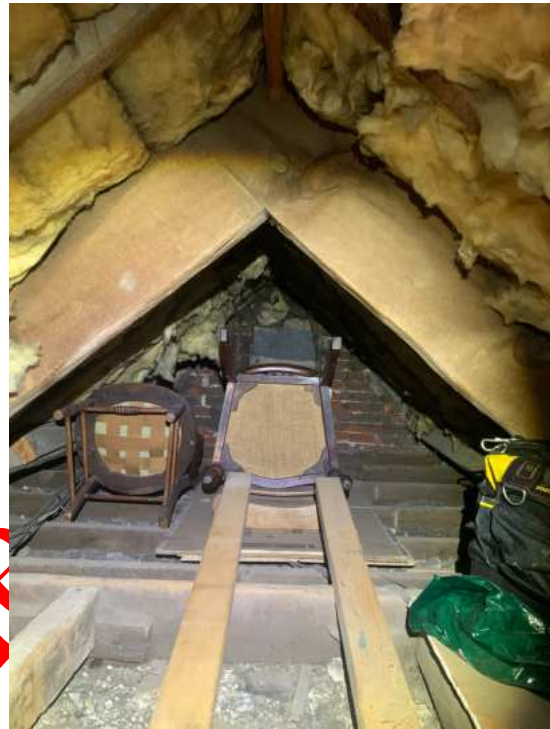
Our inspection of the loft void was extremely restricted due to the limited height, and we were limited to a 'head and shoulders' inspection at the hatch only. Stored items also severely restricted our view.

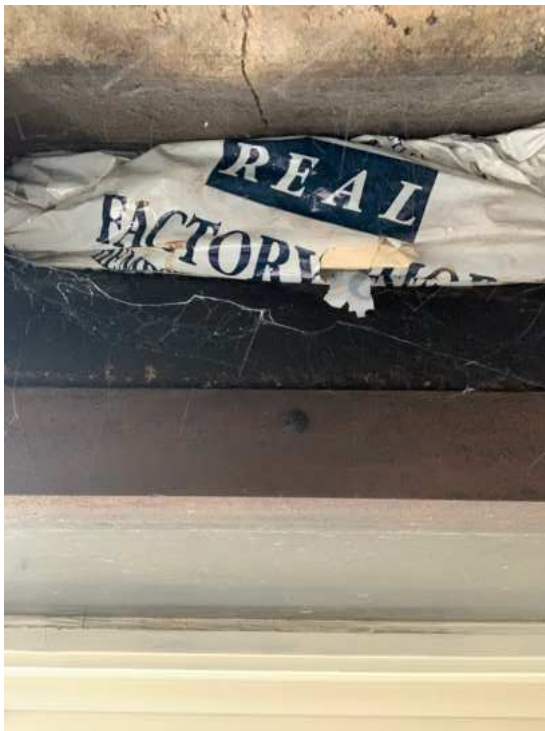
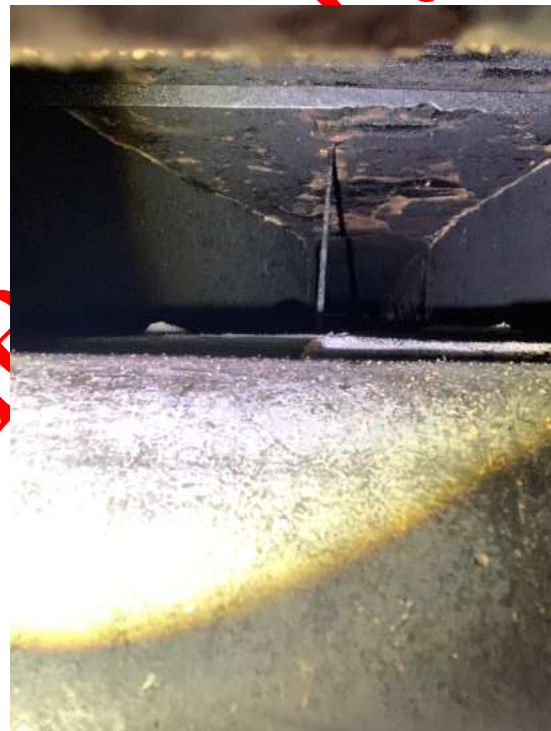
We cannot comment on the condition or adequacy of flues or the existence of any flue liners, but always recommend careful sweeping prior to usage. **Condition Rating NI.**

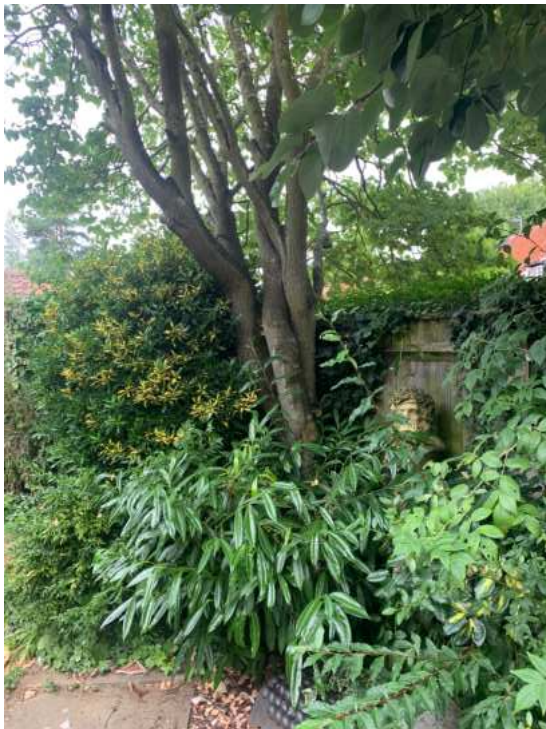
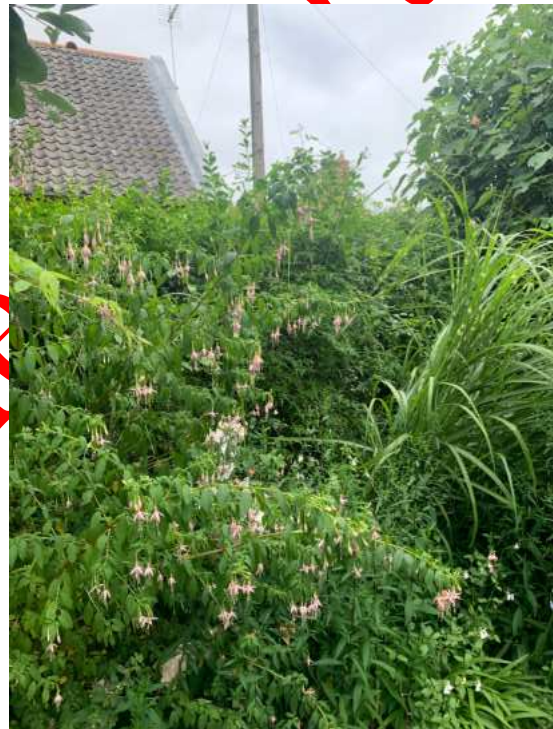
Our inspection of the boundaries was severely restricted by mature planting.

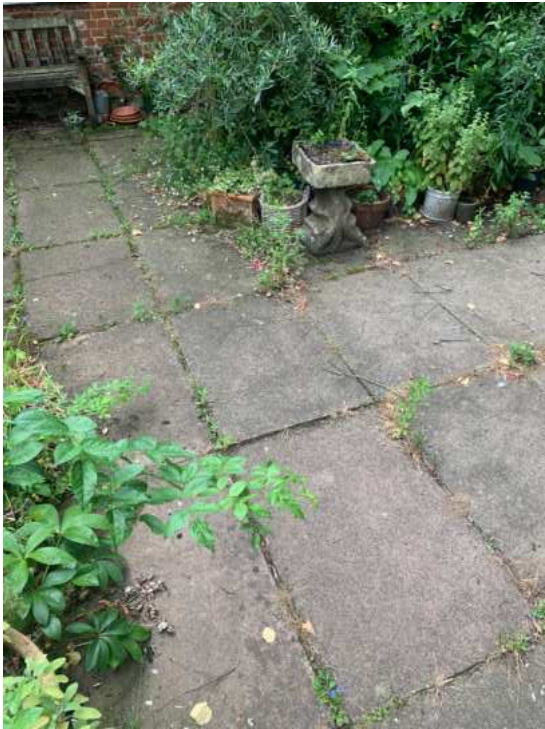
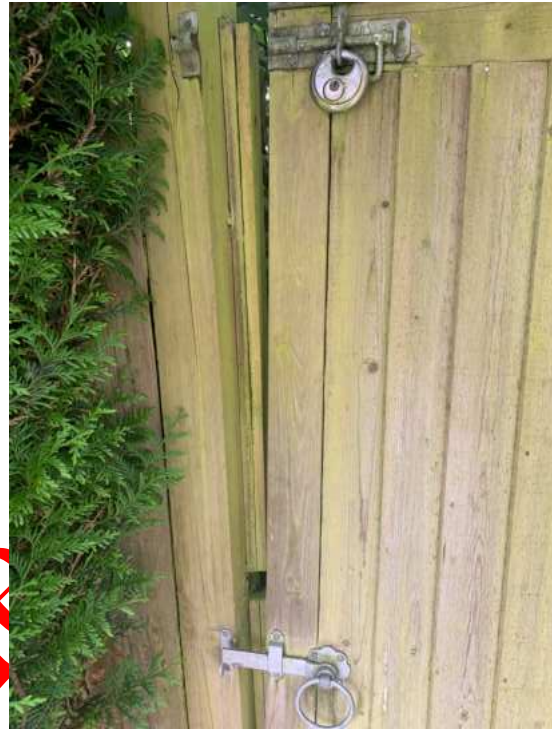
The majority of the boundaries were completely overgrown and could not be inspected. Paving is in generally average condition with some weed growth visible, and minor heave/movement from nearby tree roots. The north gate is in poor condition and not secure, you may wish to consider upgrading security provision and replacement of the gate and its posts may be more economical than attempted repairs.

2
